## MEMORANDUM

**To:** Kristopher Houle, DER  
**From:** Neal Price  
**Date:** June 30, 2021  
**Re:** Ipswich Mills Dam Removal – Summary of Spring 2021 Project Work: EBSCO Geophysical Study, EBSCO-Area Hydrologic Evaluation, and In-River Sediment Properties

The Horsley Witten Group, Inc. (HW) is pleased to submit to the Massachusetts Division of Ecological Restoration (DER) the following memorandum summarizing recent work completed in the spring of 2021 on the Ipswich Mills Dam Removal Feasibility Project (the Project). These work items included:

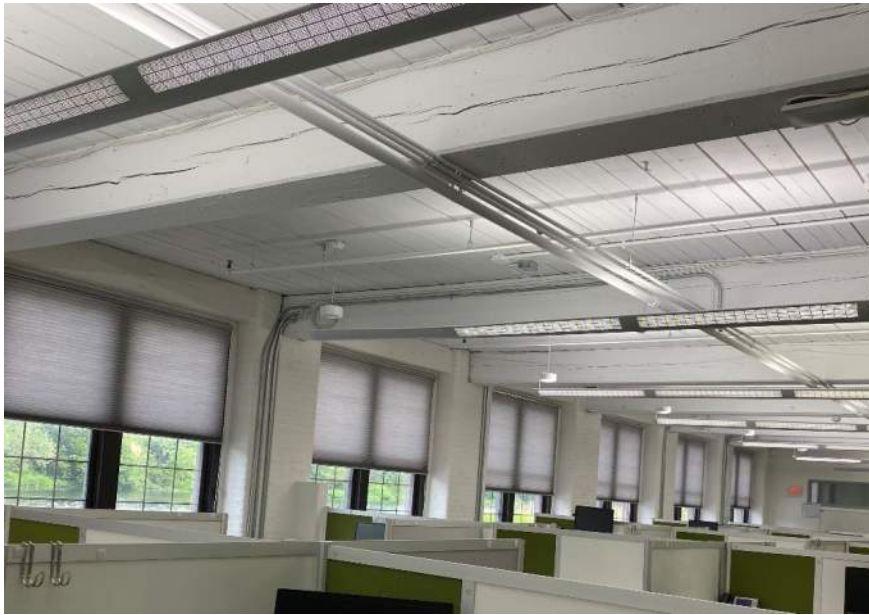
**Photo 14**

Gap between beams above Column B7.

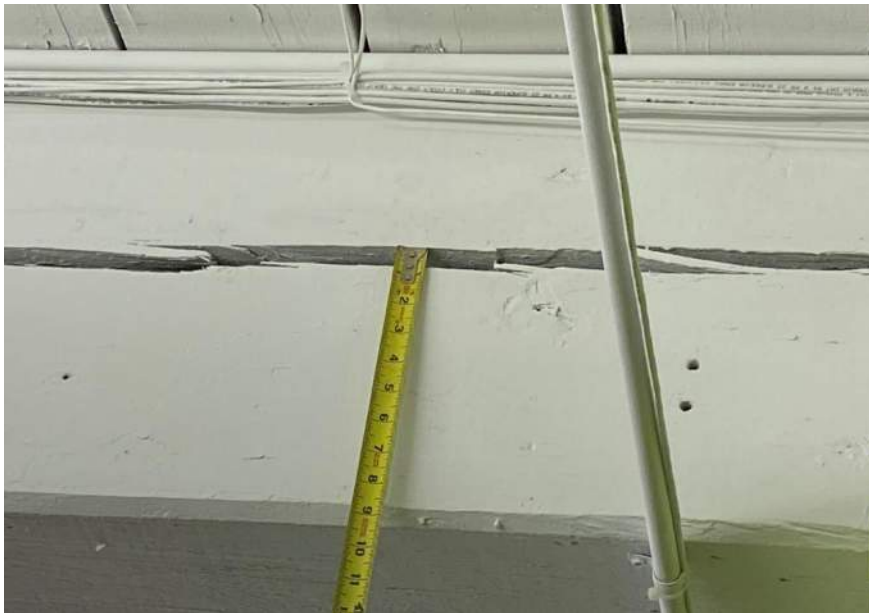
**Photo 15**

Timber beams with checking (cracking parallel to the grain).

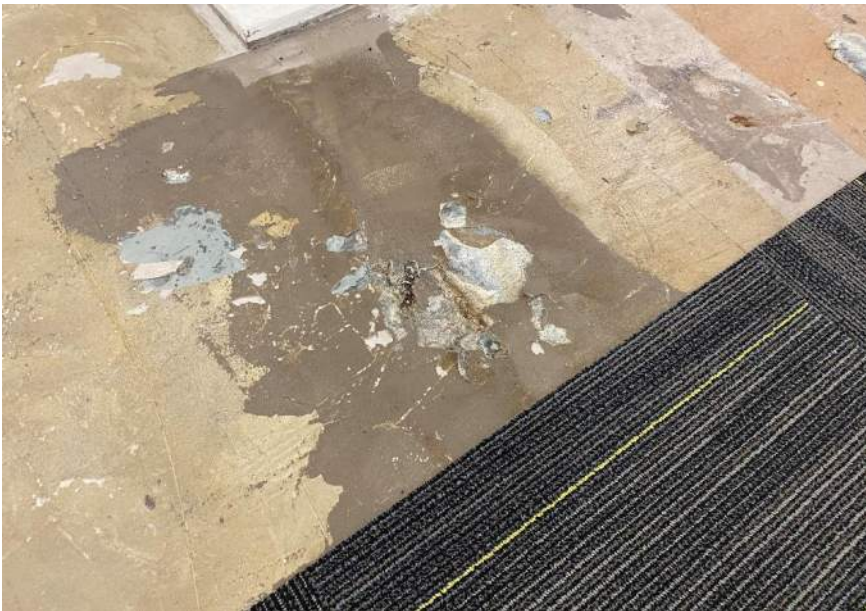
**Photo 18**

We temporarily removed carpet tiles to expose the concrete floor slab around Column B5 to provide access for RSI to perform impact echo testing. The floor slab has been covered with a patching or leveling compound material, and there were no cracks visible where the floor is sloped.

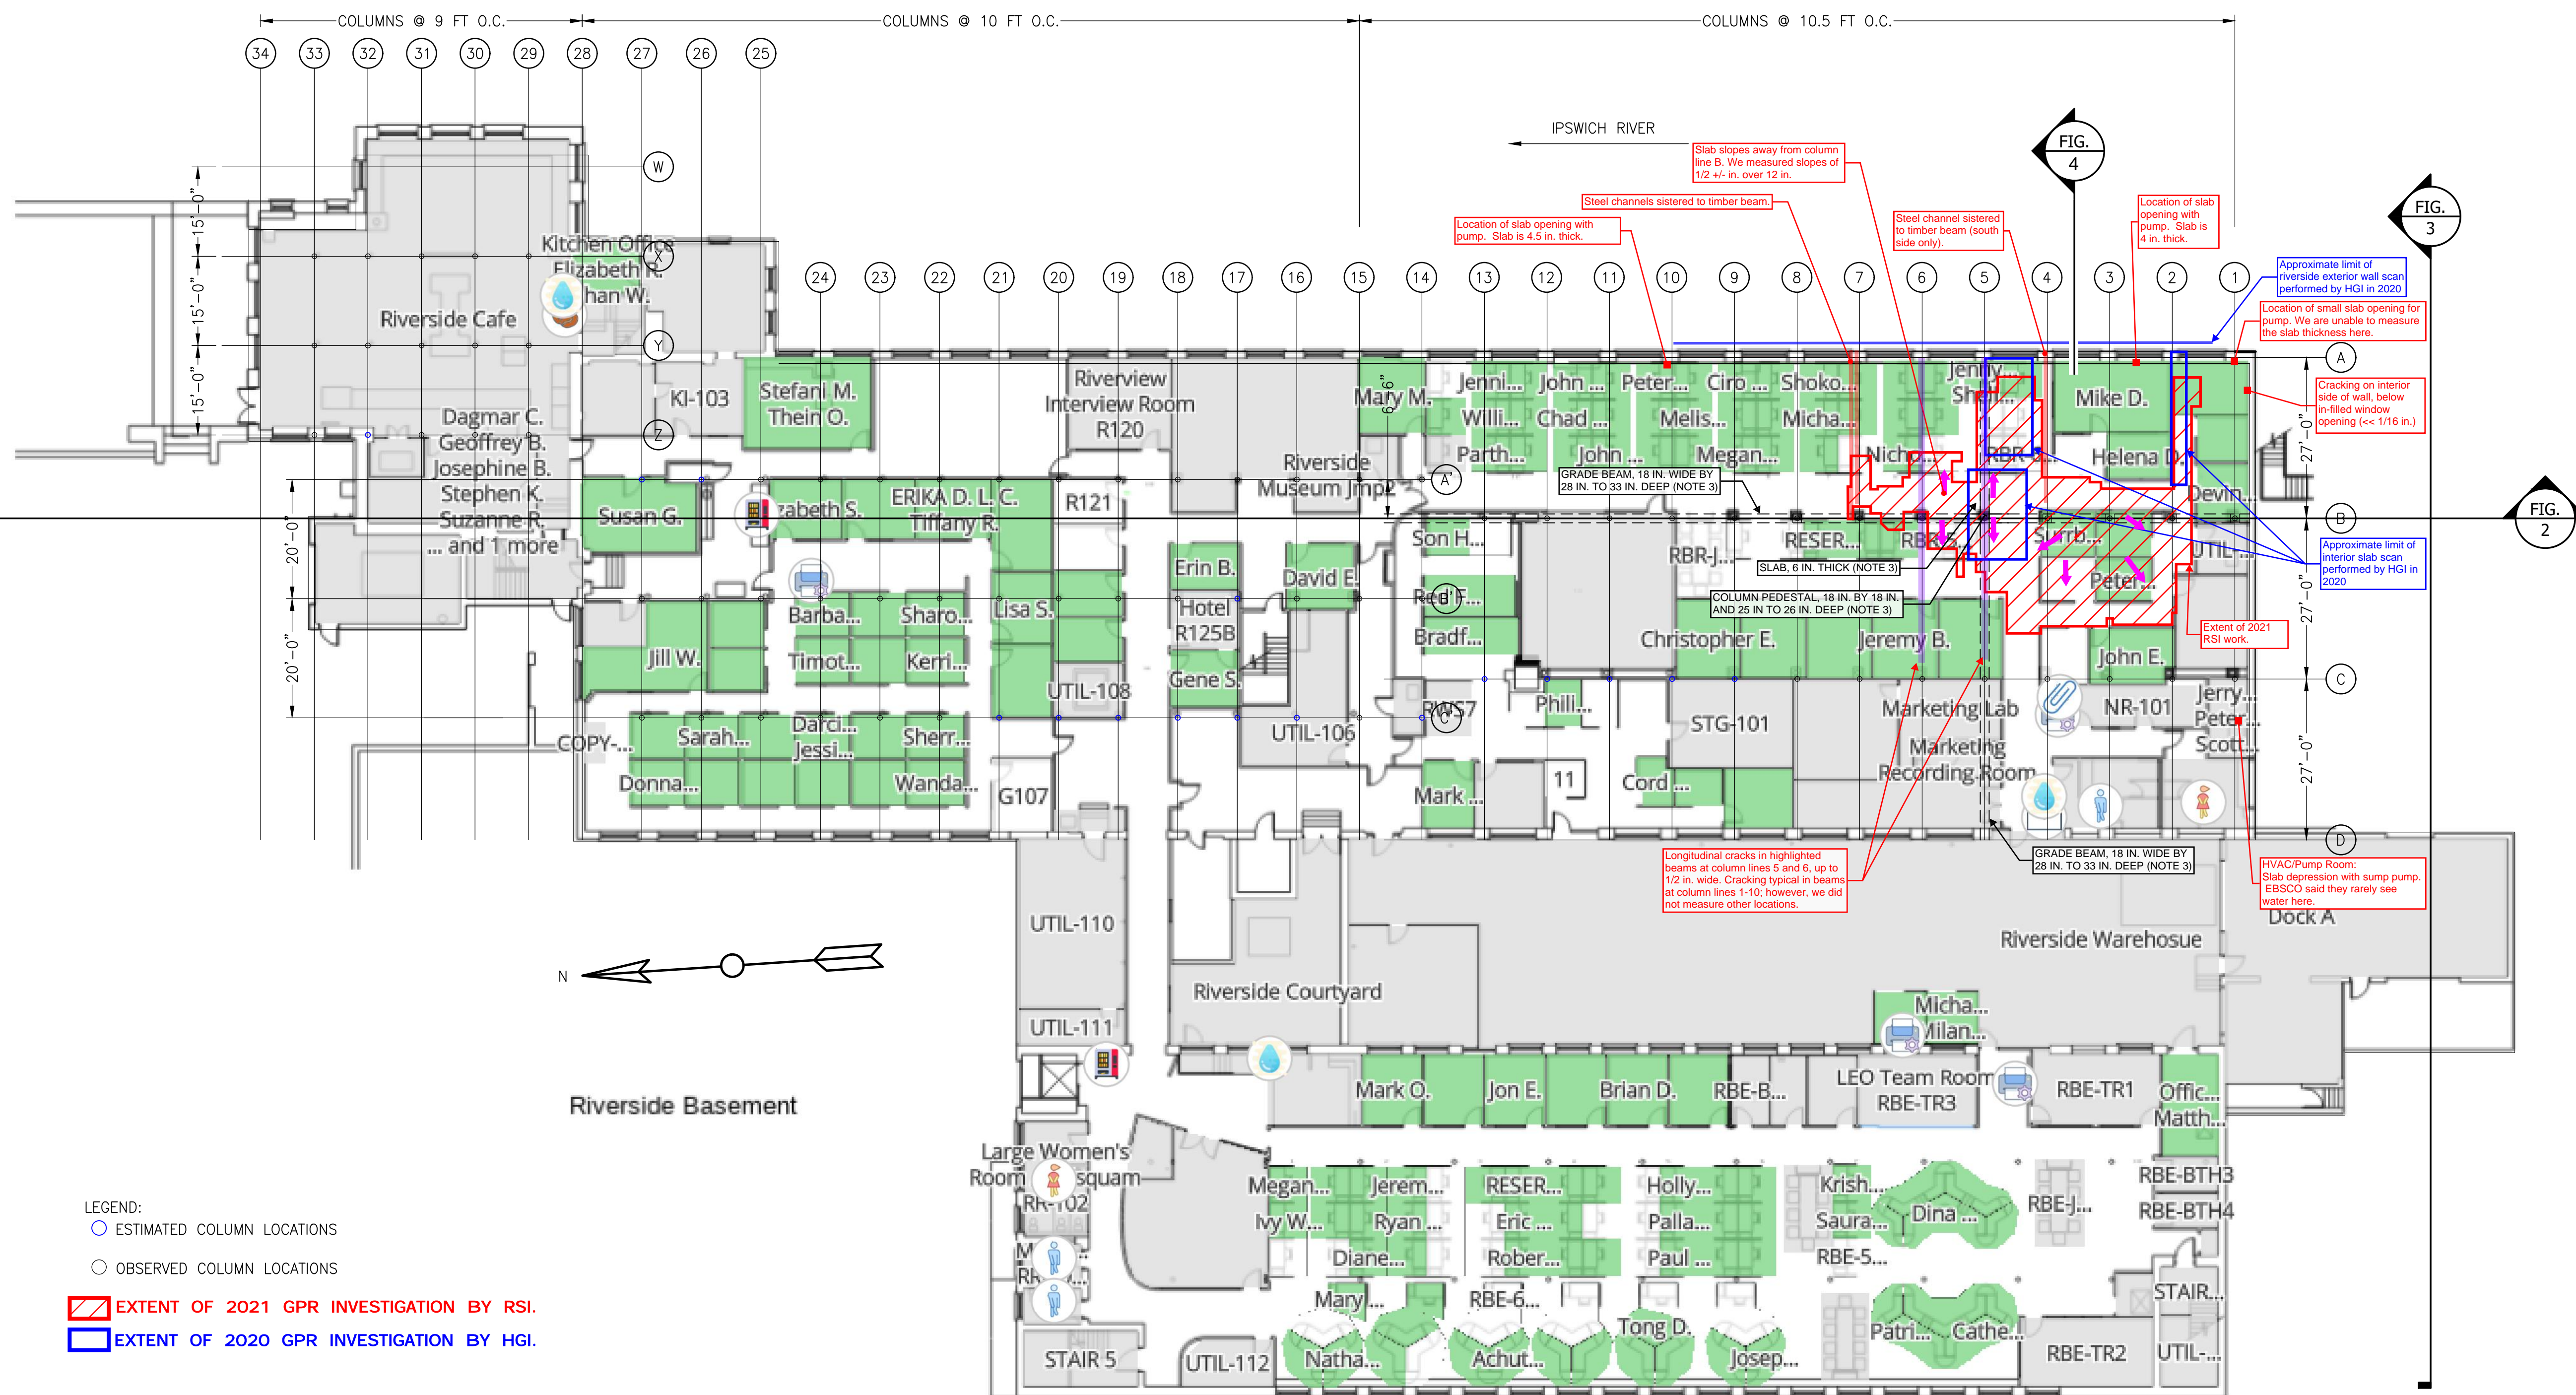
Step cracking, less than 1/16 in. wide, on the interior face of the south elevation masonry bearing wall, between Column Lines A and B.

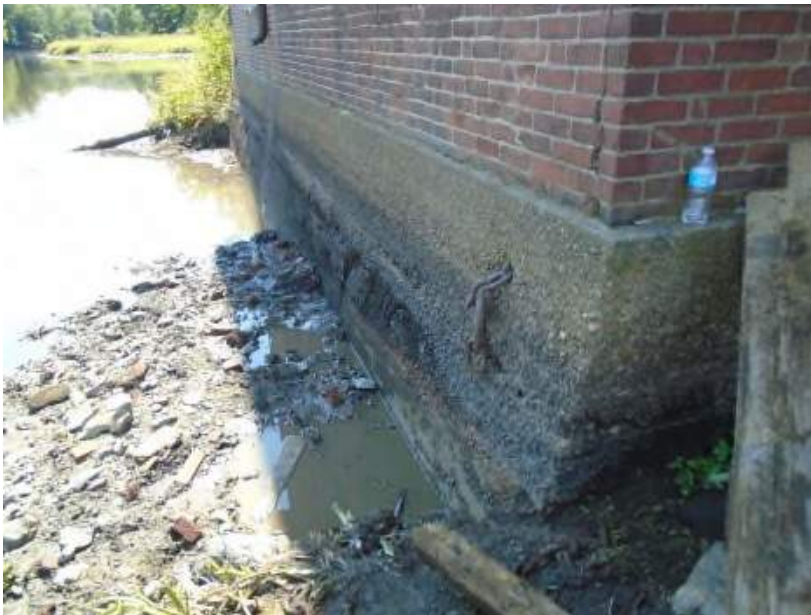
**Photo 5**

Typical rip rap and debris removed from TP-1.

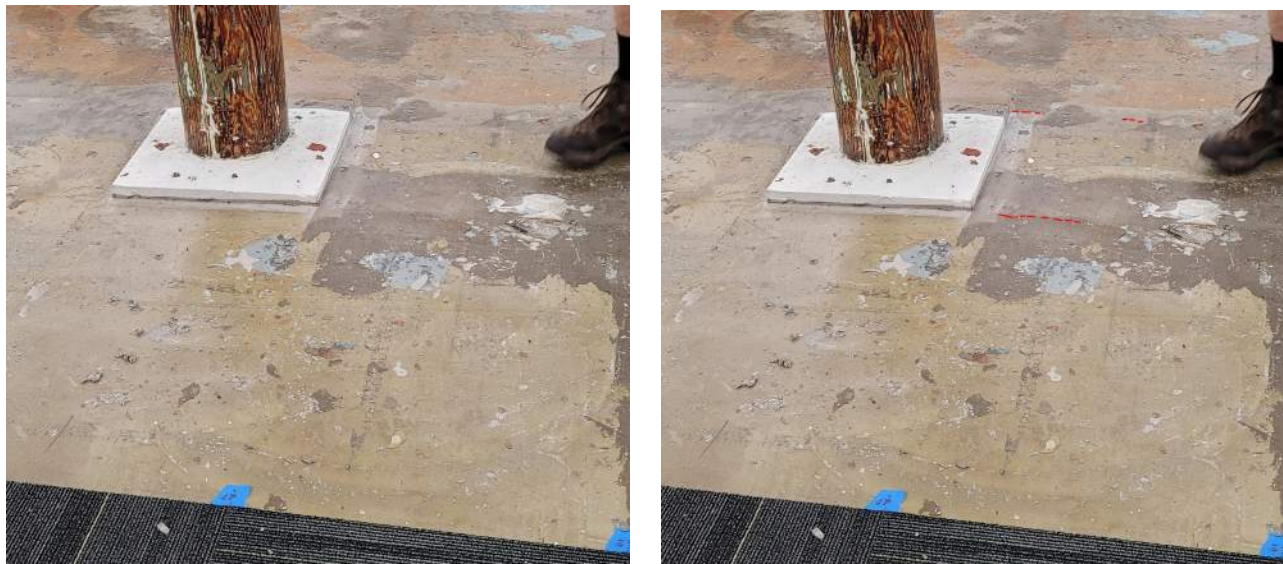
In order to use IE around a 10x8 foot box surrounding Column 5, the carpeted tiles had to be removed, exposing the bare concrete. The surface showed several defects, including several areas of spalled and chipped concrete, and a long crack about 10 inches west of the column line and paralleling it. The long crack delineates the boundary from where the slab appears to be level, from where the slab appears to be settling. The photo (LEFT) shows the most prominent crack, while the RIGHT photo shows the same photo, but annotated.

This observation shows physical evidence for the presence of a grade beam. The surface condition of the concrete was problematic for getting sufficient energy into the concrete, as

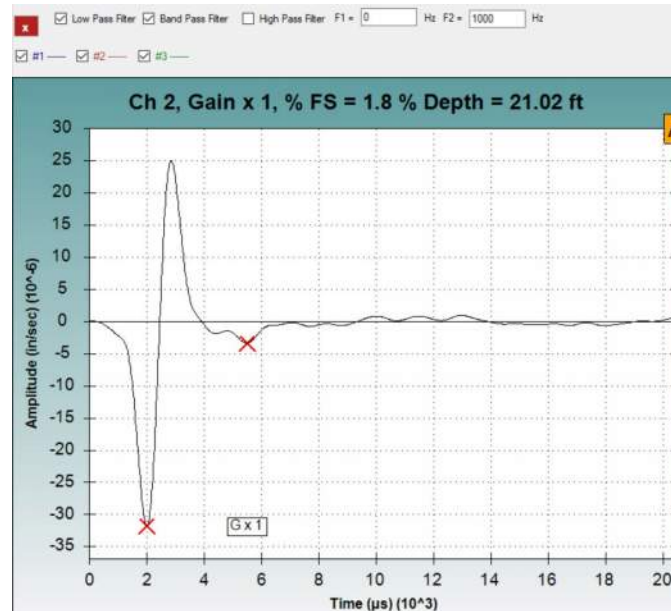
SEIR data from outside the building was used to evaluate foundation wall depths of the south and east walls, respectively. Figure 8 summarizes the depth of the foundation walls based upon location along the wall. Below is an example amplitude plot located about 50 feet east of the southwest corner between the original building and addition. Note that the highest reflection after the hammer reflection attributed to the hammer is negative, indicating that the material beneath the concrete wall has a lower impedance than the concrete.

SEIR data indicate that the south wall deepens away from the new addition, where the south foundation wall is about 18 feet in depth 2 feet east of the corner, and deepens to 21 feet in the middle of the wall, between 35 and 50 feet east of the SW corner. At the southeast corner of the historic building, the wall appears to be about 20 feet along the south and east walls (Figure 5). North from the SE corner of the building, the east wall appears to shallow, going from about a 19 foot depth 6 feet north of the SE corner to about 17 feet at 9.5 feet north of the corner. Please note, data on the east wall is of lesser quality than along the south foundation wall. We observe vertical cracking along the east wall about 1 foot north of the middle station. We also observe horizontal cracking in one location along the east wall. Reflections from these internal cracks of the foundation wall create noise in the data.

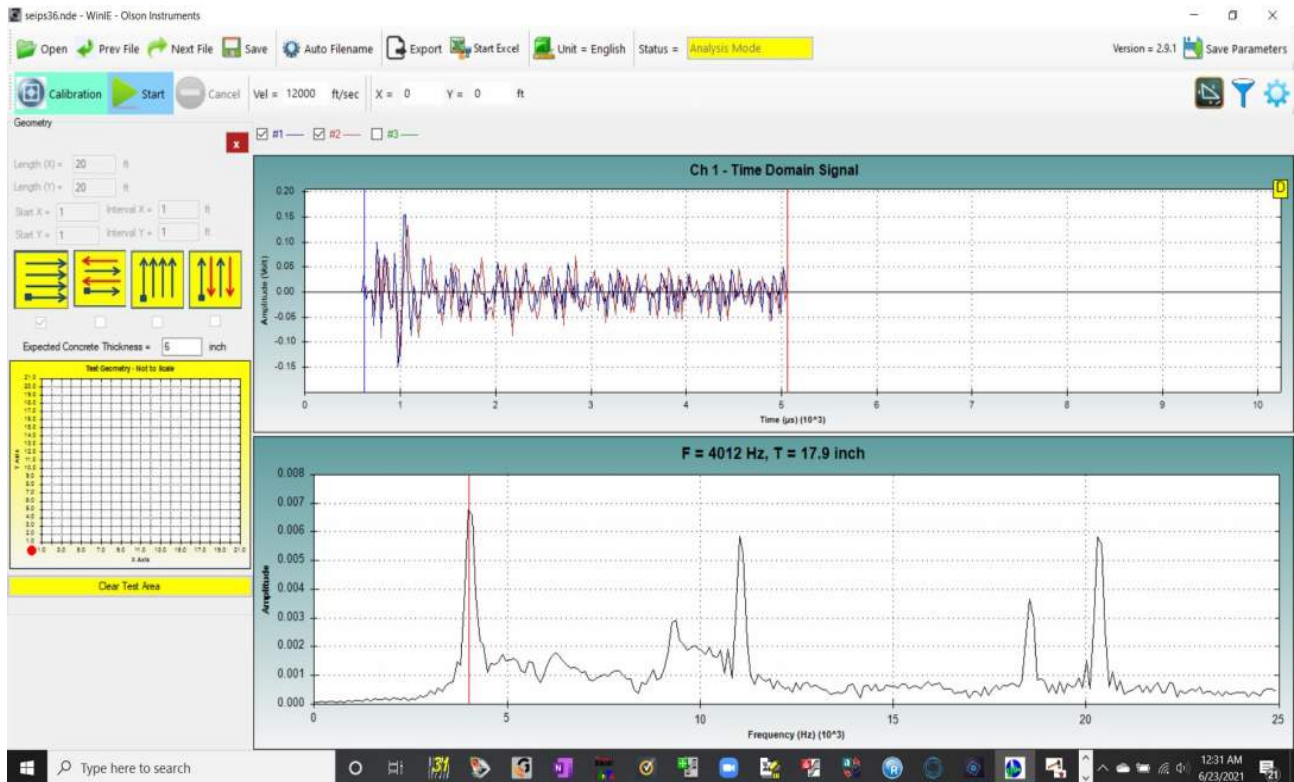
Evaluation of IE data, the results of which are presented on Figure 9, were a little more challenging due to the top of the foundation wall getting closer to grade as one moves to the east along the south foundation wall. Hence, we could only obtain IE readings only at the western most stations, and of that, only the station at 22E, located 22 feet east of the SW corner between the addition and original buildings, produced good data. Here, IE indicates that the south wall has a thickness at the top of about 18 inches. Below is the record from Station 22E. The highest peak is from the actual wall-fill interface, while the other peaks are from ambient electrical noise. The top of the south foundation wall was not exposed east of Station 22E.

Along the east foundation wall, we were able to make two measurements, 2.5 and about 8 feet north of the SE corner (Figure 9). IE data at these locations indicate that the east foundation wall thickness at the top is about 2 feet in thickness.
