# Site Reconnaissance for Ipswich River Dams

June 2006

# **1.0 IPSWICH RIVER DAMS**

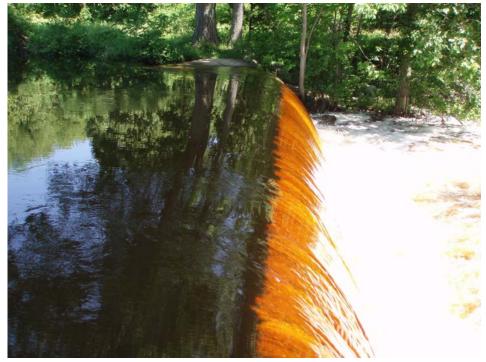
Photo 1: Bostik Dam

The Bostik Dam is privately owned and currently provides water storage for an industrial facility. The primary use of the stored water is for fire suppression. The overall width of the dam is approximately 100 feet (ft), including a reported<sup>1</sup> spillway width of 47 ft long. A manually operated sluice gate with an approximate width of 10 ft is situated between the right abutment of the dam and the spillway. The hydraulic height of the dam was not measured during the site visit on account of high flows. The reported<sup>1</sup> height is six ft. The construction of the dam is reported as "stone and concrete."<sup>1</sup> Observations suggest that the dam is partially founded on bedrock.

The owner of this dam currently maintains a warning sign to recreational boaters upstream of the dam. Limited access to the Bostik industrial facility and fencing adjacent to the right abutment precludes casual access to the dam. There are no physical restrictions to access to the left abutment. Conditions observed during the site visit suggest that hydraulic conditions immediately downstream of the dam form a "keeper" during periods of high flow; this represents a significant hazard to a person swept over the dam.

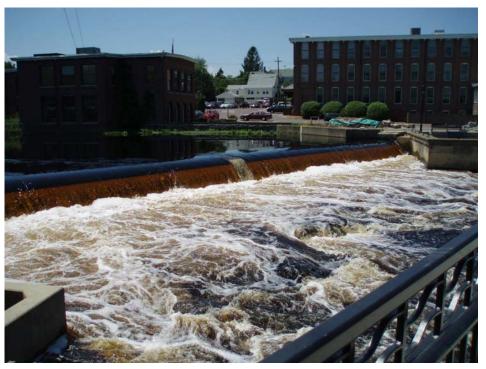
The EBSCO Dam is owned by the Town of Ipswich. The dam has an overall length of approximately 200 ft, including an overflow spillway approximately 120 ft long. There is no low-level outlet. A Denil fishpass was installed in 1995 adjacent to the right abutment to replace an abandoned pool-and-weir fishway.

Removal of the EBSCO Dam could provide substantial benefits to natural resources in the Ipswich River, including passage of diadromous fish. Although a fishpass was recently constructed at this dam, it does not provide upstream passage for rainbow smelt (*Osmerus mordax*), which currently spawn in the Ipswich River downstream of the dam. In addition, there are no dedicated provisions for downstream fish passage.

Figure 2: Abandoned Pools and Weir Fishpass (left) and Denil Fishpass (right)

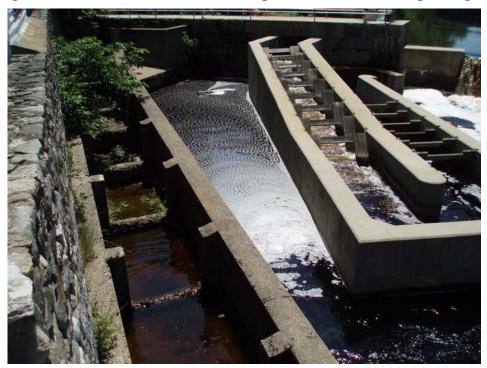
Figure 1: EBSCO Dam

Currently the dam has no functional use. The backwater extent, and volume and quality of sedimented material were not evaluated as part of this study. The lack of exclusionary fencing and ease of public access represent a potential hazard. The channel is confined by steep embankments and retaining wall downstream from the dam, representing a safety hazard during periods of high flow.

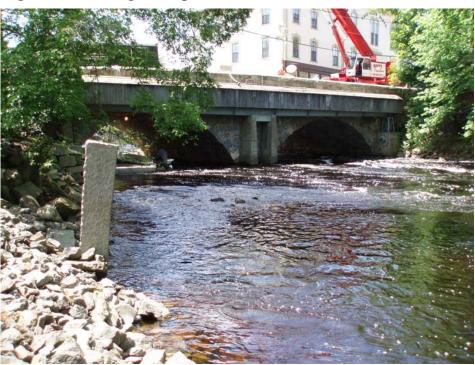
Removal of the EBSCO dam would likely result in diminished flooding upstream of the dam and the restoration of riverine habitat in the Ipswich River. Constraints associated with dam removal include potential effects on two bridges downstream of the dam and loss of recreational opportunities associated with the upstream impoundment. The former constraint may be addressed through a detailed engineering analysis of flooding along this reach of the Ipswich River. Observations made during the site visit suggest that flood storage benefits associated with the upstream impoundment are minimal, due to 1) observations by others that the spillway was nearly "drown-out" during recent flood events, 2) the contraction in the river channel immediately downstream of the dam possibly acting as a hydraulic control during high flow events, and 3) the dam not being operated to maximize flood control benefits. Socio-economic constraints to dam removal may be addressed through the dissemination of information regarding potential benefits of dam removal, including reduced flooding and alternative recreational opportunities.

Figure 3: First Bridge over Ipswich River Downstream from EBSCO Dam

Suggested technical analyses include unsteady (i.e., time-variant) hydraulic analyses and associated evaluations of pre- and post-removal effects on infrastructure (e.g., bridge scour) and flooding.
