RE: Supplemental Information – Ipswich Mills Dam Removal Expanded Environmental Notification Form

PHASE I

INSPECTION/EVALUATION REPORT

Dam Name:	Ipswich Mills Dam
State ID#:	5-5-144-4
NID ID #:	MA00231
Owner Type:	Municipal
Owner:	Town of Ipswich
Town:	Ipswich, MA
Consultant:	Tetra Tech, Inc.
Date of Inspection:	September 4, 2020

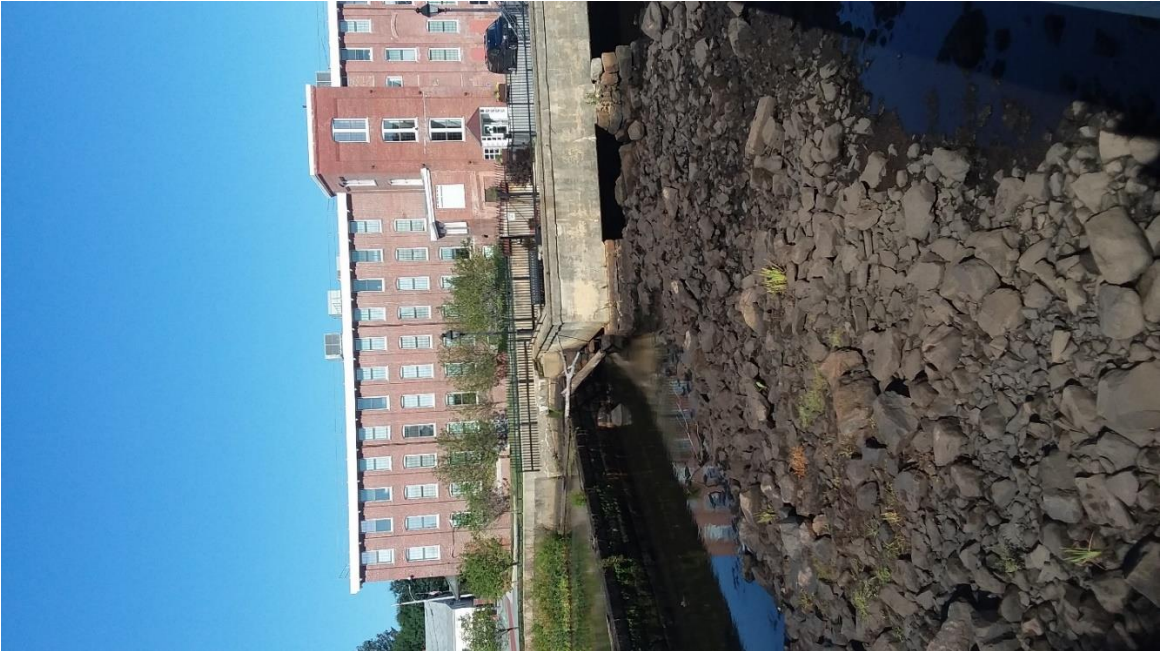
The left abutment walls consist of layers of previous constructions and a patchwork of concrete and granite blocks dating to each iteration of construction. As reported in the 2009 Inspection Report, the left abutment leaked in 1948 and caused a scour hole to develop. Several attempts to fix the leaks were only partially successful and in 1952 a whirlpool developed resulting in an emergency condition. Gravel was dumped into the scour and leaks were plugged. Other than brief notes about the leaks and mention of a whirlpool, details of the fix are not available. The location of the leak would be below a constructed parking lot and walkway deck at the dam site today and the area is not accessible for inspection. Leaks or unusual flow at the left abutment were not observed during the 2020 inspection. Cracks in the left abutment wall exist at some locations, which are similar to the 2009 inspection; however, the left abutment appears to be in fair condition.

Photograph 6 – Dam left abutment looking from footbridge

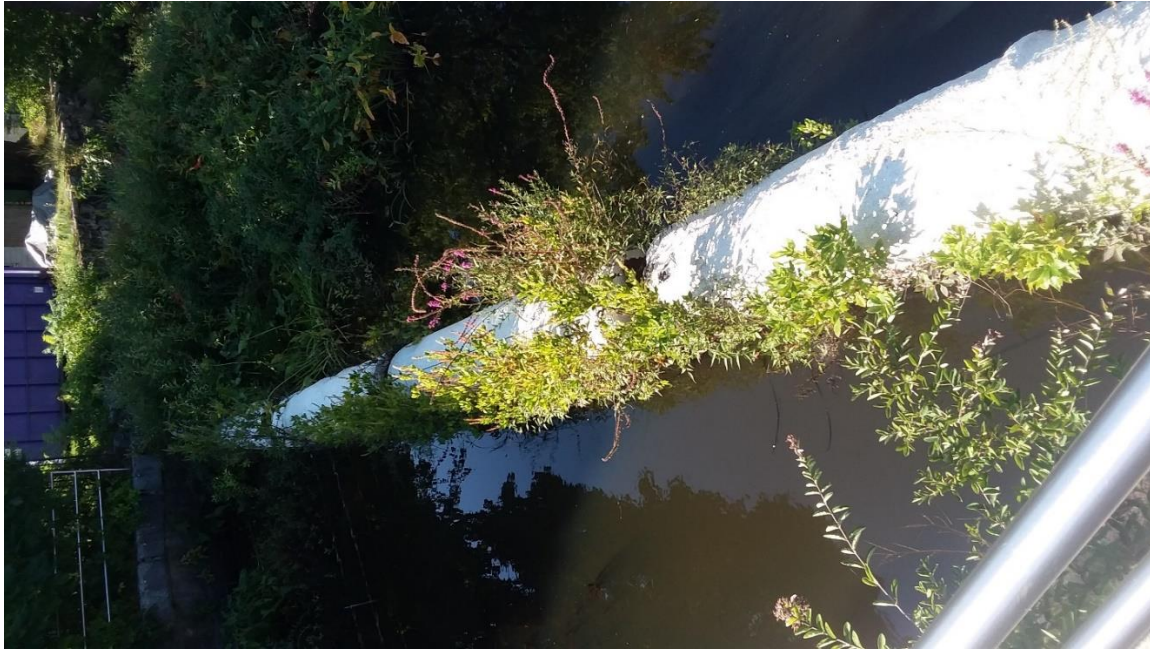
An approximately 2 ft diameter log boom is located upstream of the granite pier and is anchored with cable to the upstream right abutment wall. The log boom consists of five boom lengths with Styrofoam covering a steel connecting rods. The steel rods are corroded with Styrofoam surfaces and protective end plates severely deteriorated. The log boom appears to be in poor condition.

Photograph 7 – Log boom upstream of fishway exit channel looking from fishway viewing area.

<u>REMEDIAL MEASURE</u>	<u>APPROXIMATE COST</u>
Remove vegetation	\$ 2,000
Remove logs from spillway crest	\$ 3,000
Replace log boom	\$ 5,000
Routine dam and spillway condition monitoring	Town Resources
Contingencies (20%)	<u>\$ 2,000</u>
Total	\$12,000

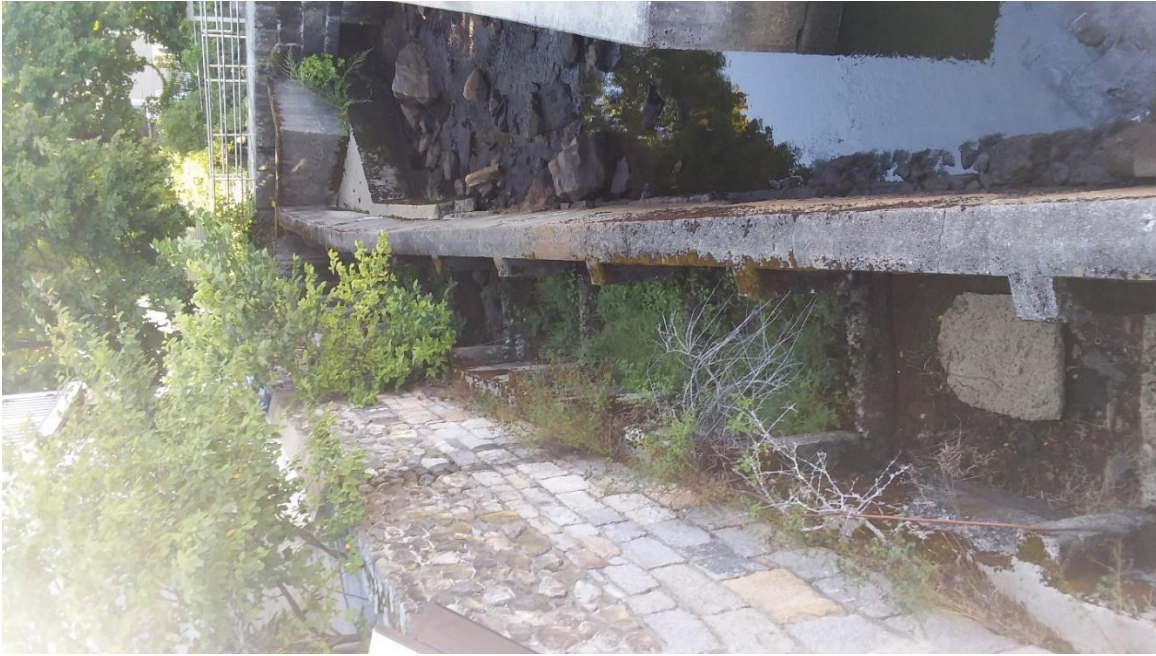
One fish ladder was a pool and weir fish ladder and was constructed prior to 1973. This fish ladder was in major disrepair by 1993 with the concrete failing and has been abandoned. This fish ladder is straight and is located against the right downstream abutment wall and extends through the granite pier where a concrete plug has been installed to eliminate flow.

Photograph 9 – Abandoned fishway along river bank wall downstream of right abutment

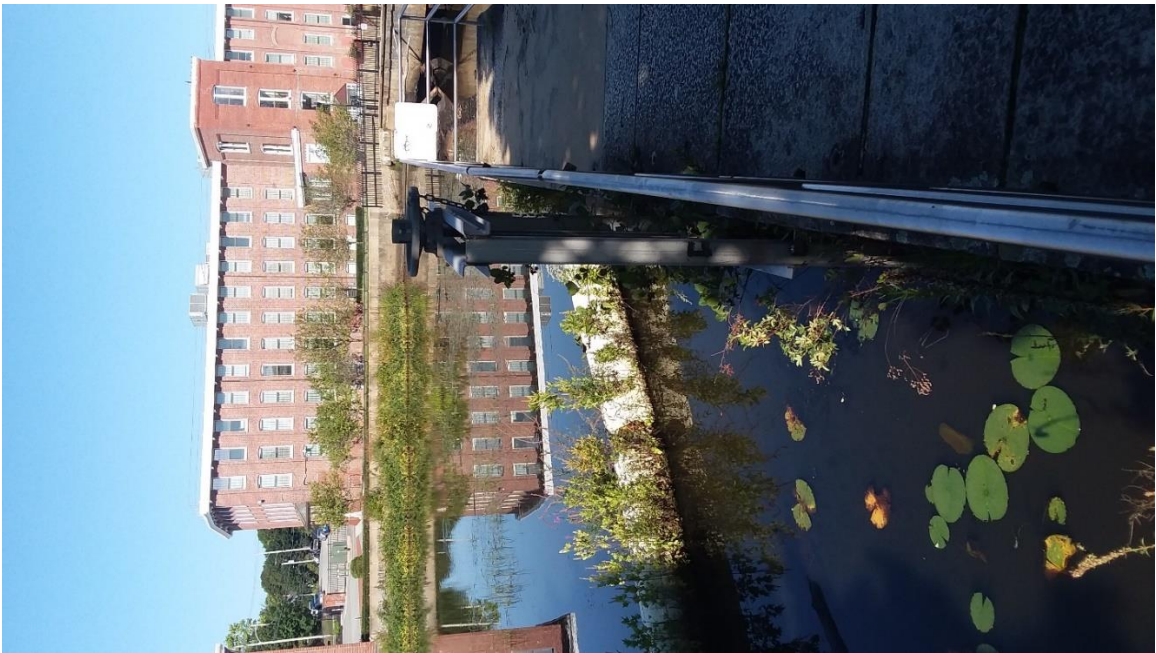
Photograph 10 – Log boom and low-level outlet gate looking from right abutment

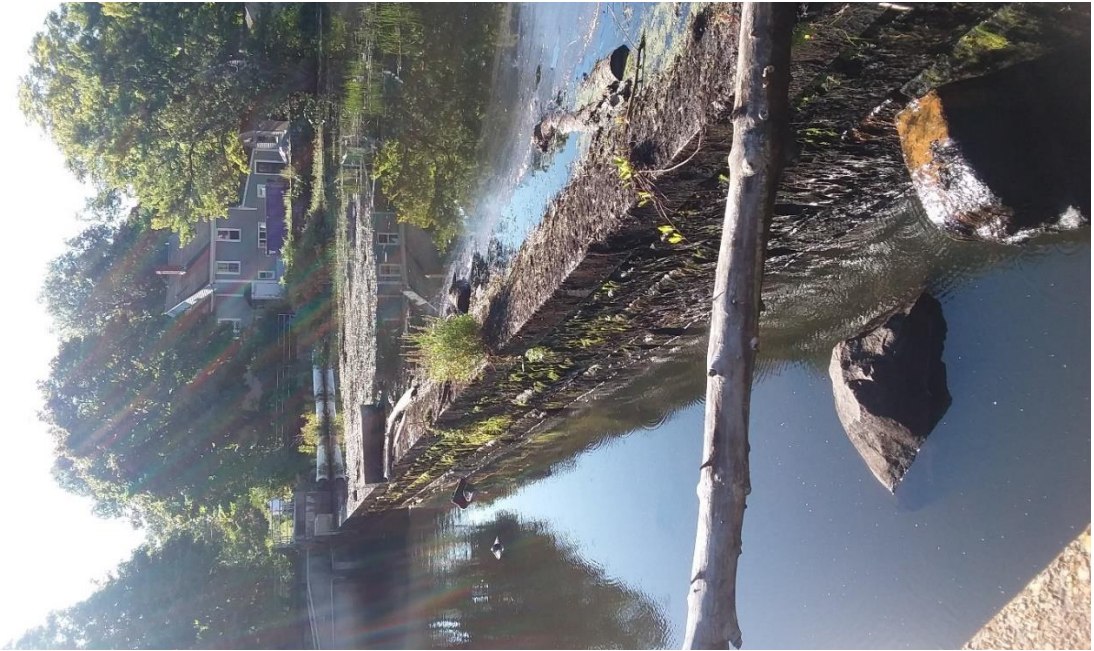
The Ipswich Mills Dam consists of a cut stone spillway mortared together with concrete and masonry repairs completed since construction of the existing dam in early 1900s. The downstream face of the spillway was visible during the site visit with no water flowing over the crest. The spillway crest appears to be in good conditions.

The 1993 inspection report included observations of open joints and recommended repointing of the joints. The 2019 Feasibility Reports indicates that the upstream was coated with a 1.5-inch thick layer of hydraulic cement sealant. Observations during the 2020 inspection indicated minimal leakage through the downstream face of the spillway indicating that the upstream face sealant is intact.

Photograph 14 – Downstream face of dam looking from left abutment

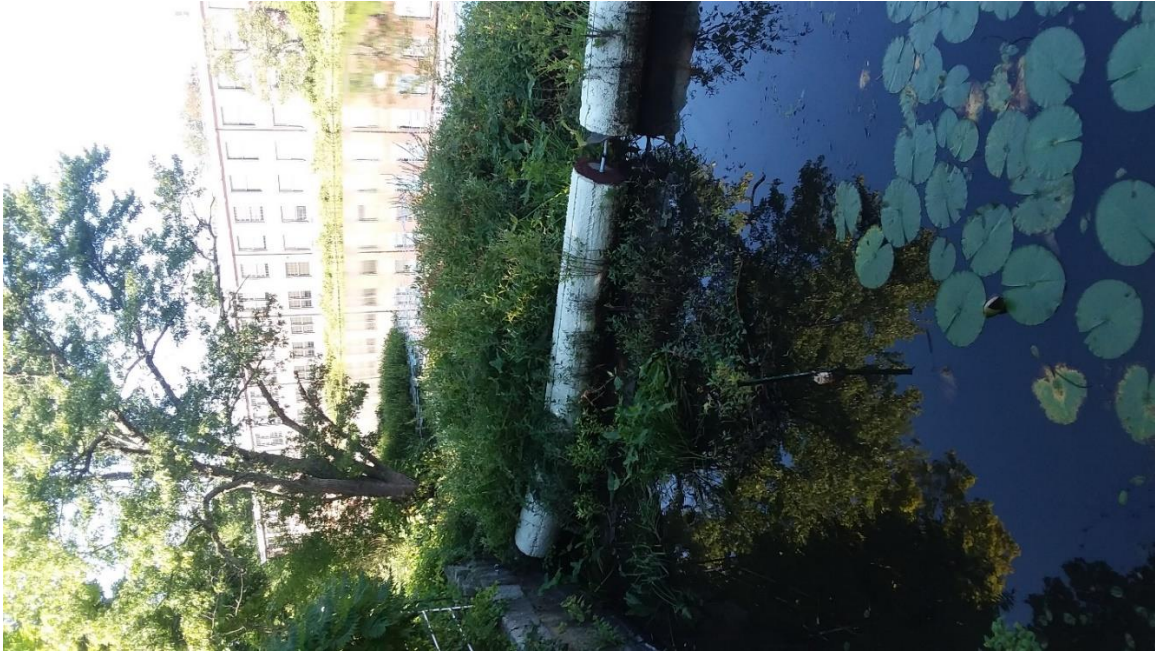
Photograph 15 – Vegetation at log boom upstream of fishway exit

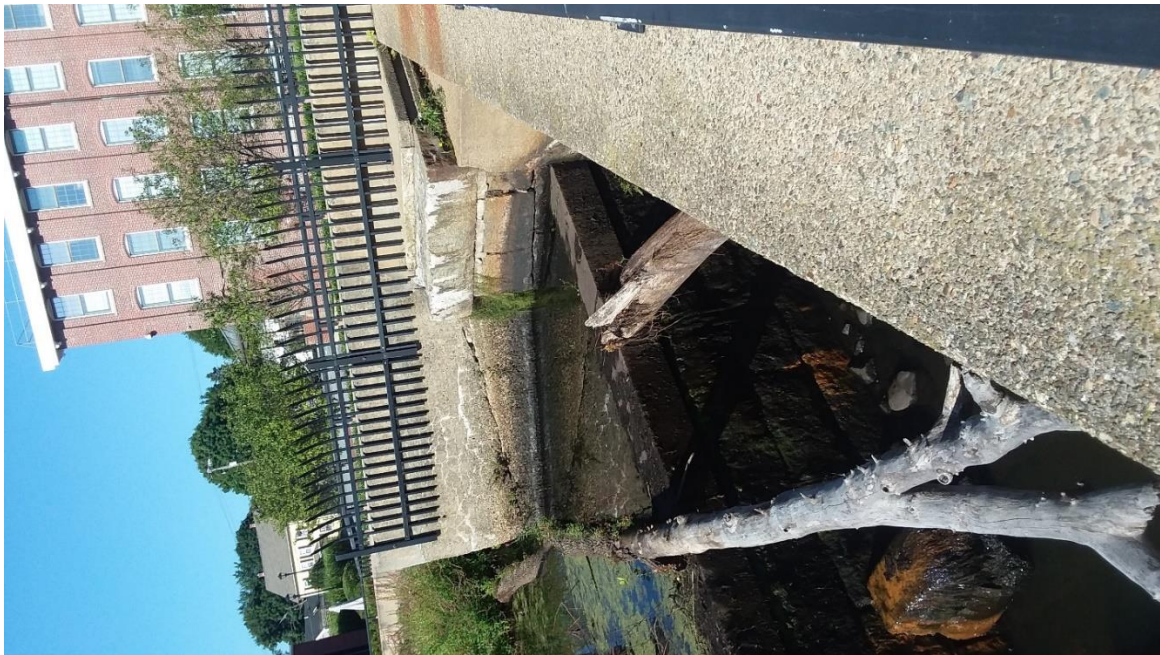
Photograph 16 – Logs on dam crest at left abutment

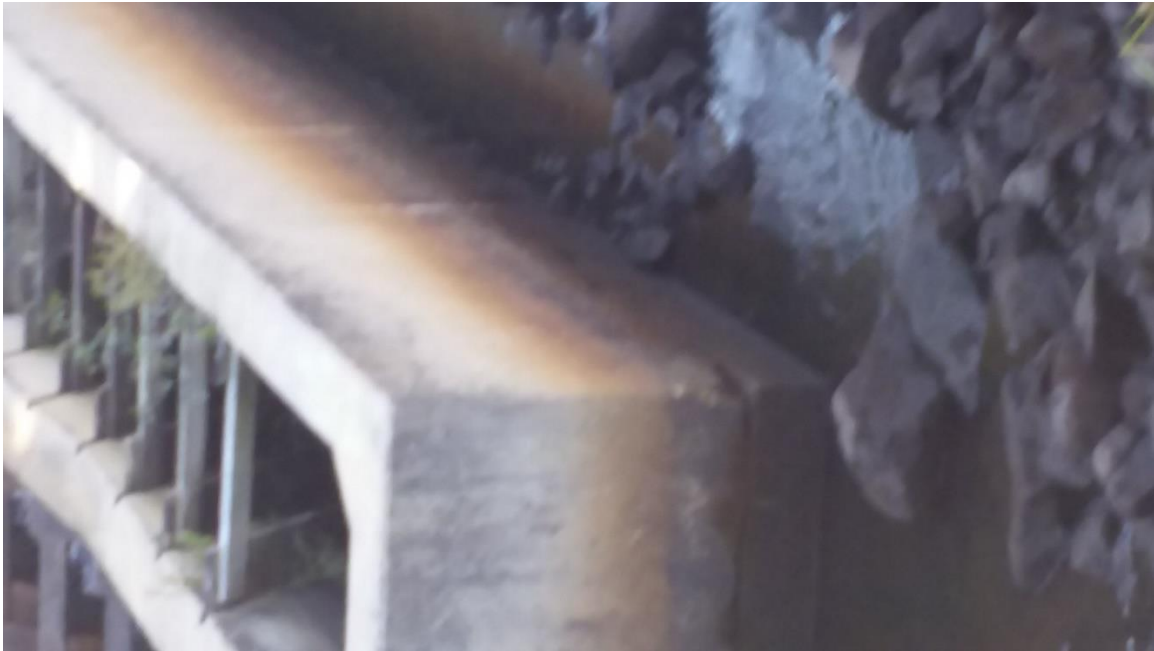
The active fish ladder was constructed in 1996 and the outlet is through the granite pier. The upstream fishway exit is through the granite pier and the outlet is fitted with stainless steel guides for stoplogs. The downstream end of the fish ladder exits adjacent to the low-level stoplog spillway. The fish ladder is operated by the Massachusetts Division of Marine Fisheries and appears to be in good condition. However, there is some concrete deterioration at the horizontal construction joint between the wall and base slab in the Denil fishway turning pool.

Photograph 18 – Concrete erosion at fishway turning pool wall and footing construction joint

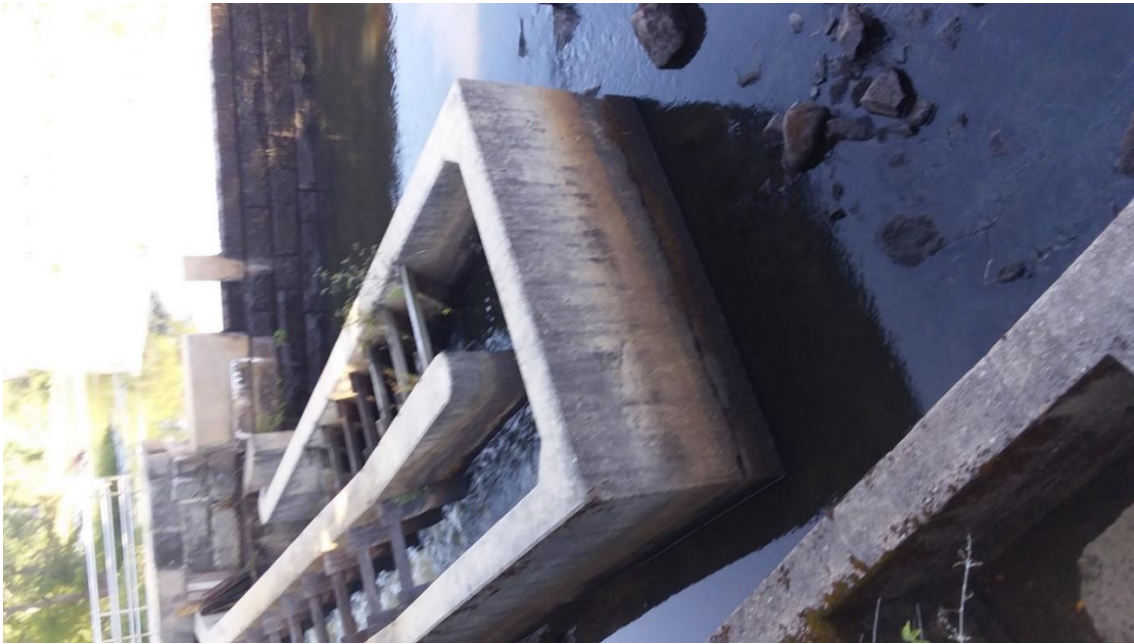
Photograph 21 – Wall and base slab construction joint concrete erosion at fishway turning pool

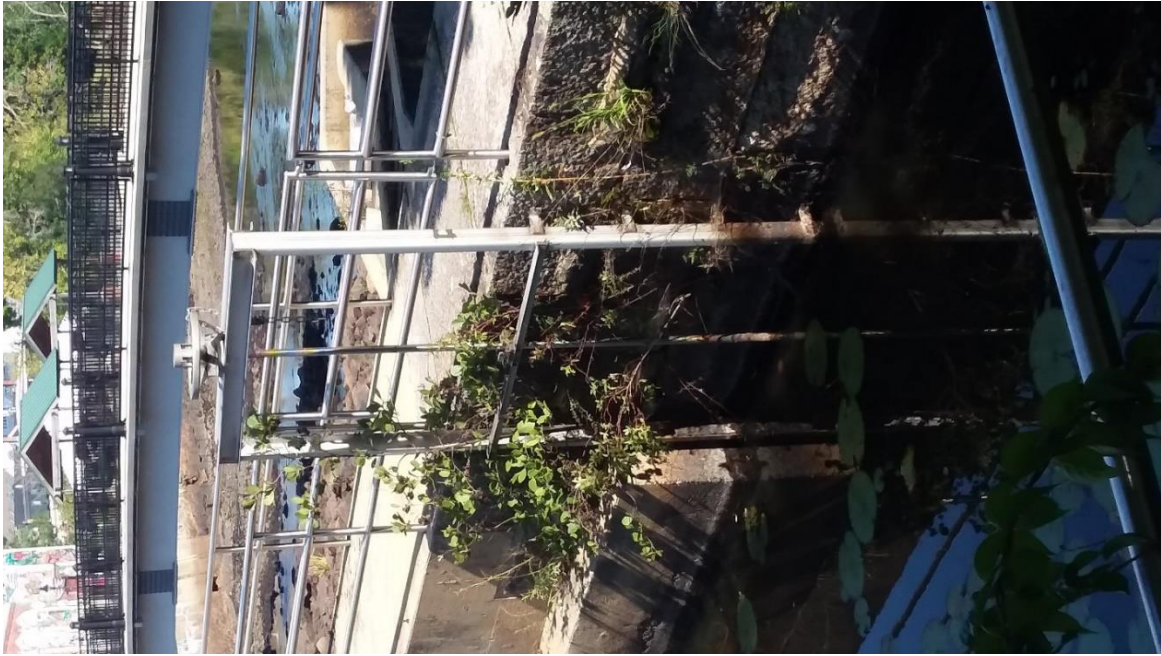
Originally, the granite pier included five low level outlets which were controlled with wooden, rack and pinion gates. Three of the outlets have been plugged and two remain in service, one provides flow to the active fish ladder and one is gated for a low-level gated outlet. The outlet works appear to be in good condition.

Photograph 31 – Low-level outlet gate looking downstream from right riverbank
