Appendix G: Due Diligence Report and
DEP Approved Sediment Sampling Plan

DUE DILLIGENCE REVIEW & SEDIMENT SAMPLING PLAN

Ipswich Mills Dam Removal February 2024

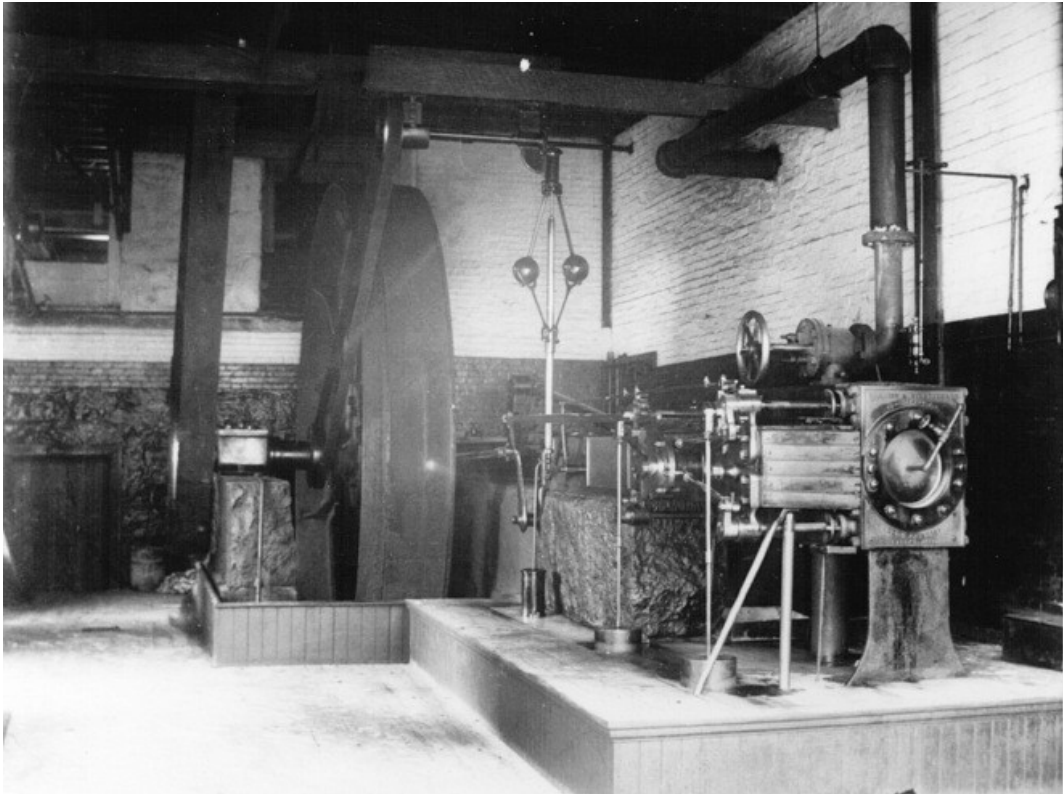
Photo 2: Water-powered machinery in the Ipswich mill. Undated photograph.

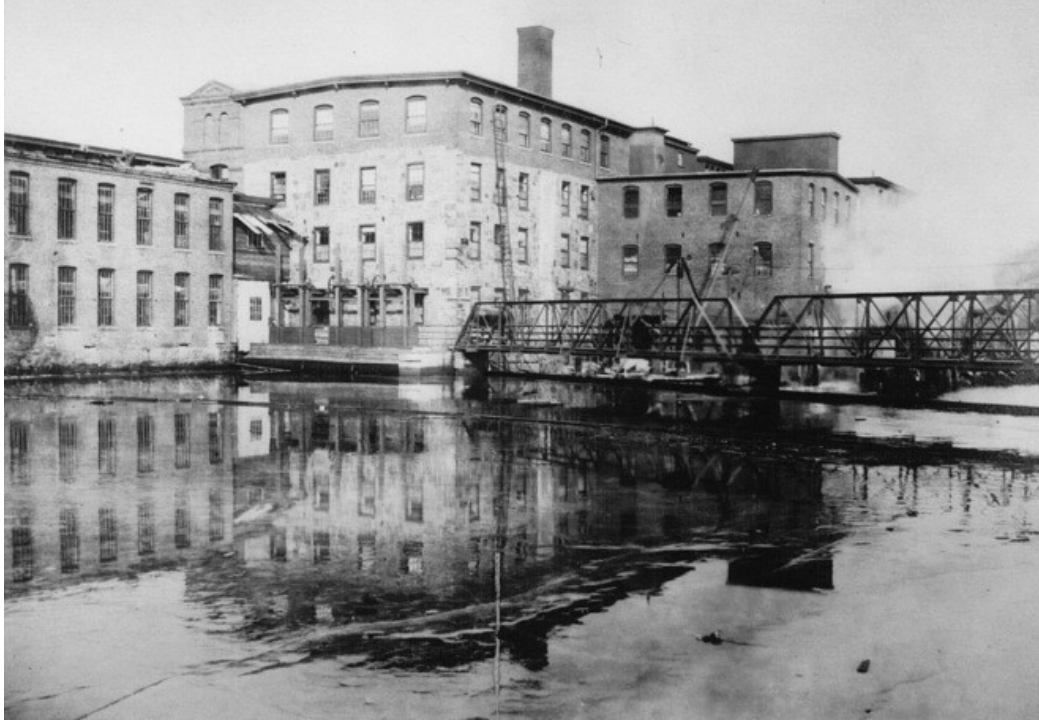
Photo 3: Ipswich Mills – View of the Mill just upstream of the dam and former pedestrian bridge circa early 20th century. The shorter building in foreground is the current EBSCO facility. The larger building no longer exists.

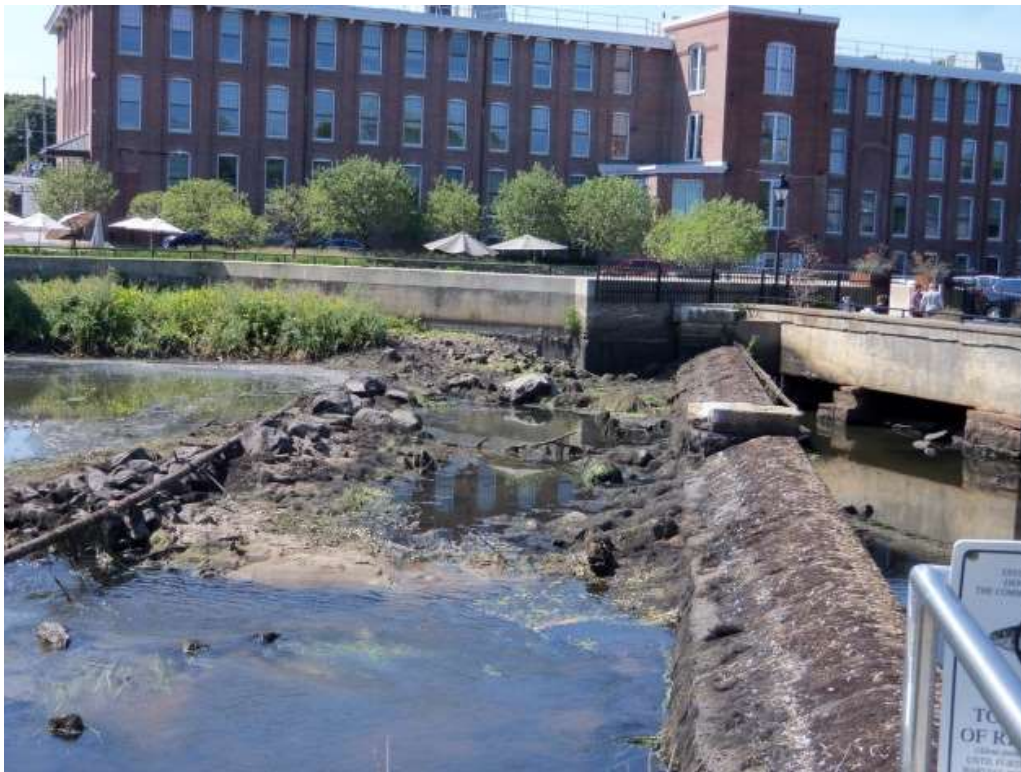
Photo 4: August 2016 Drawdown – The Ipswich River was drawn down behind the dam to better assess conditions in the impoundment, and an old gas line for the mill was exposed.

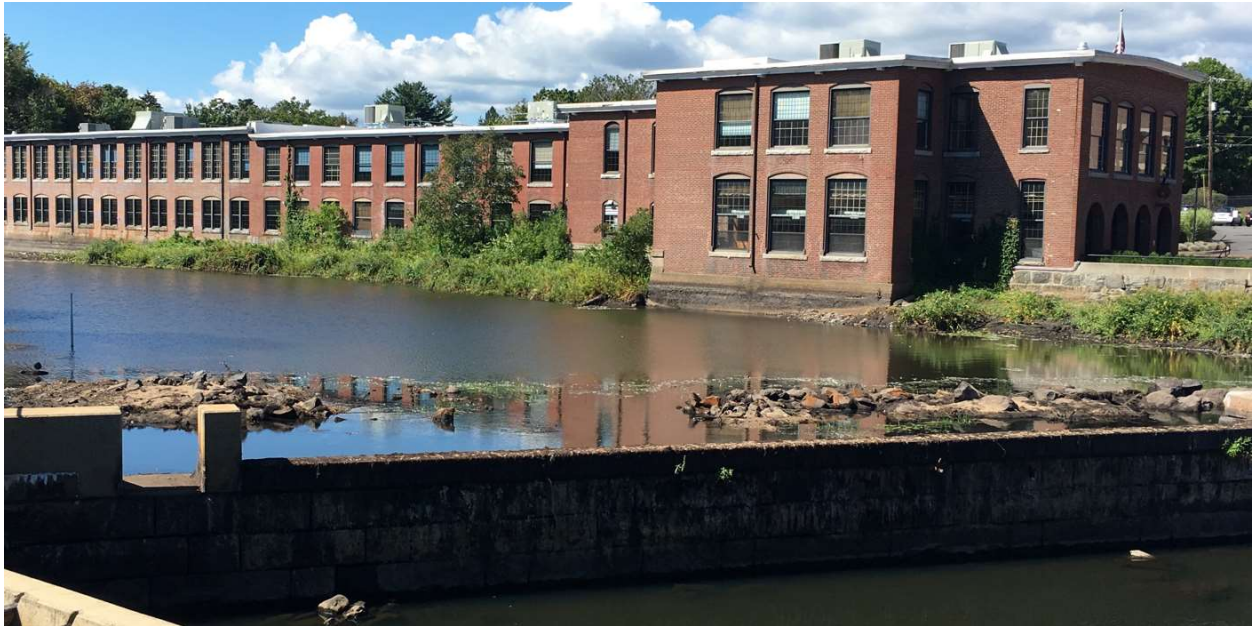
Photo 5: August/ September 2016 drawdown showing gas line removed.

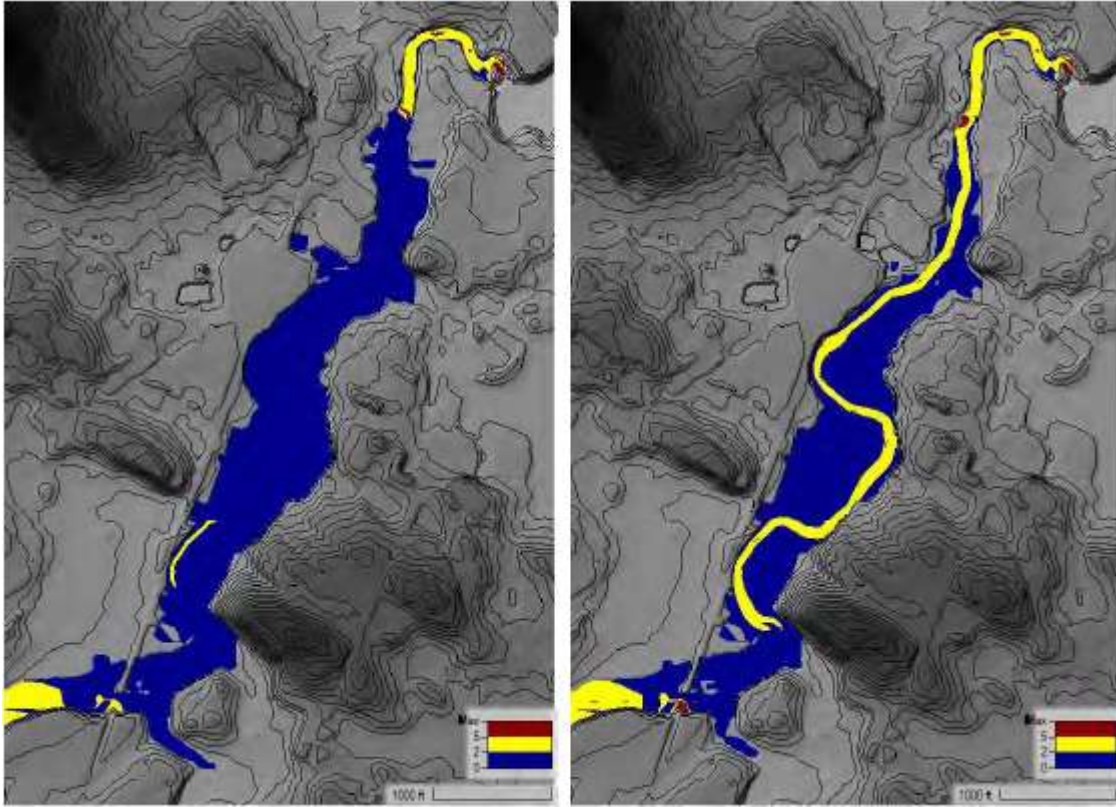
Figure 4. Anticipated Sediment Transport Areas from H&H Modeling

Blue: no sediment transport expected (0-2fps)

Yellow: transport of silt is feasible (2-5 fps)

Maroon: transport of silt, sand, and gravel is feasible (5 fps or greater)

Hydrologic and Hydraulic (H&H) Modeling completed during the dam removal project's assessment and design phase identified the areas in the impoundment upstream of the dam where sediment is likely to mobilize and downstream where mobilized sediment is likely to settle. Figure 4 (also depicted as Figure 20 from the figure's original location within the Project's Basis of Design report) below depicts existing and post-dam removal flow velocity conditions for the 2-year storm event. The 2-year event is the channel forming flow condition where the highest velocities tend to occur in the most spatially focused locations, encouraging erosion. Higher flow events tend to overtop channel banks and spread out over wider areas such that erosive velocities are lesser. On Figure 4, the yellow indicates areas where silt and finer sand size particles are likely to mobilize, and the red indicates areas where larger sand and gravel particles are likely to mobilize. As evident in Figure 4, sediment mobilization is anticipated over a broader area immediately upstream of the dam and is mostly confined to a narrower channel within the confines of the current impoundment further upstream.
