## MEMORANDUM

**To:** Kristopher Houle, DER  
**From:** Neal Price  
**Date:** June 30, 2021  
**Re:** Ipswich Mills Dam Removal – Summary of Spring 2021 Project Work: EBSCO Geophysical Study, EBSCO-Area Hydrologic Evaluation, and In-River Sediment Properties

The Horsley Witten Group, Inc. (HW) is pleased to submit to the Massachusetts Division of Ecological Restoration (DER) the following memorandum summarizing recent work completed in the spring of 2021 on the Ipswich Mills Dam Removal Feasibility Project (the Project). These work items included:

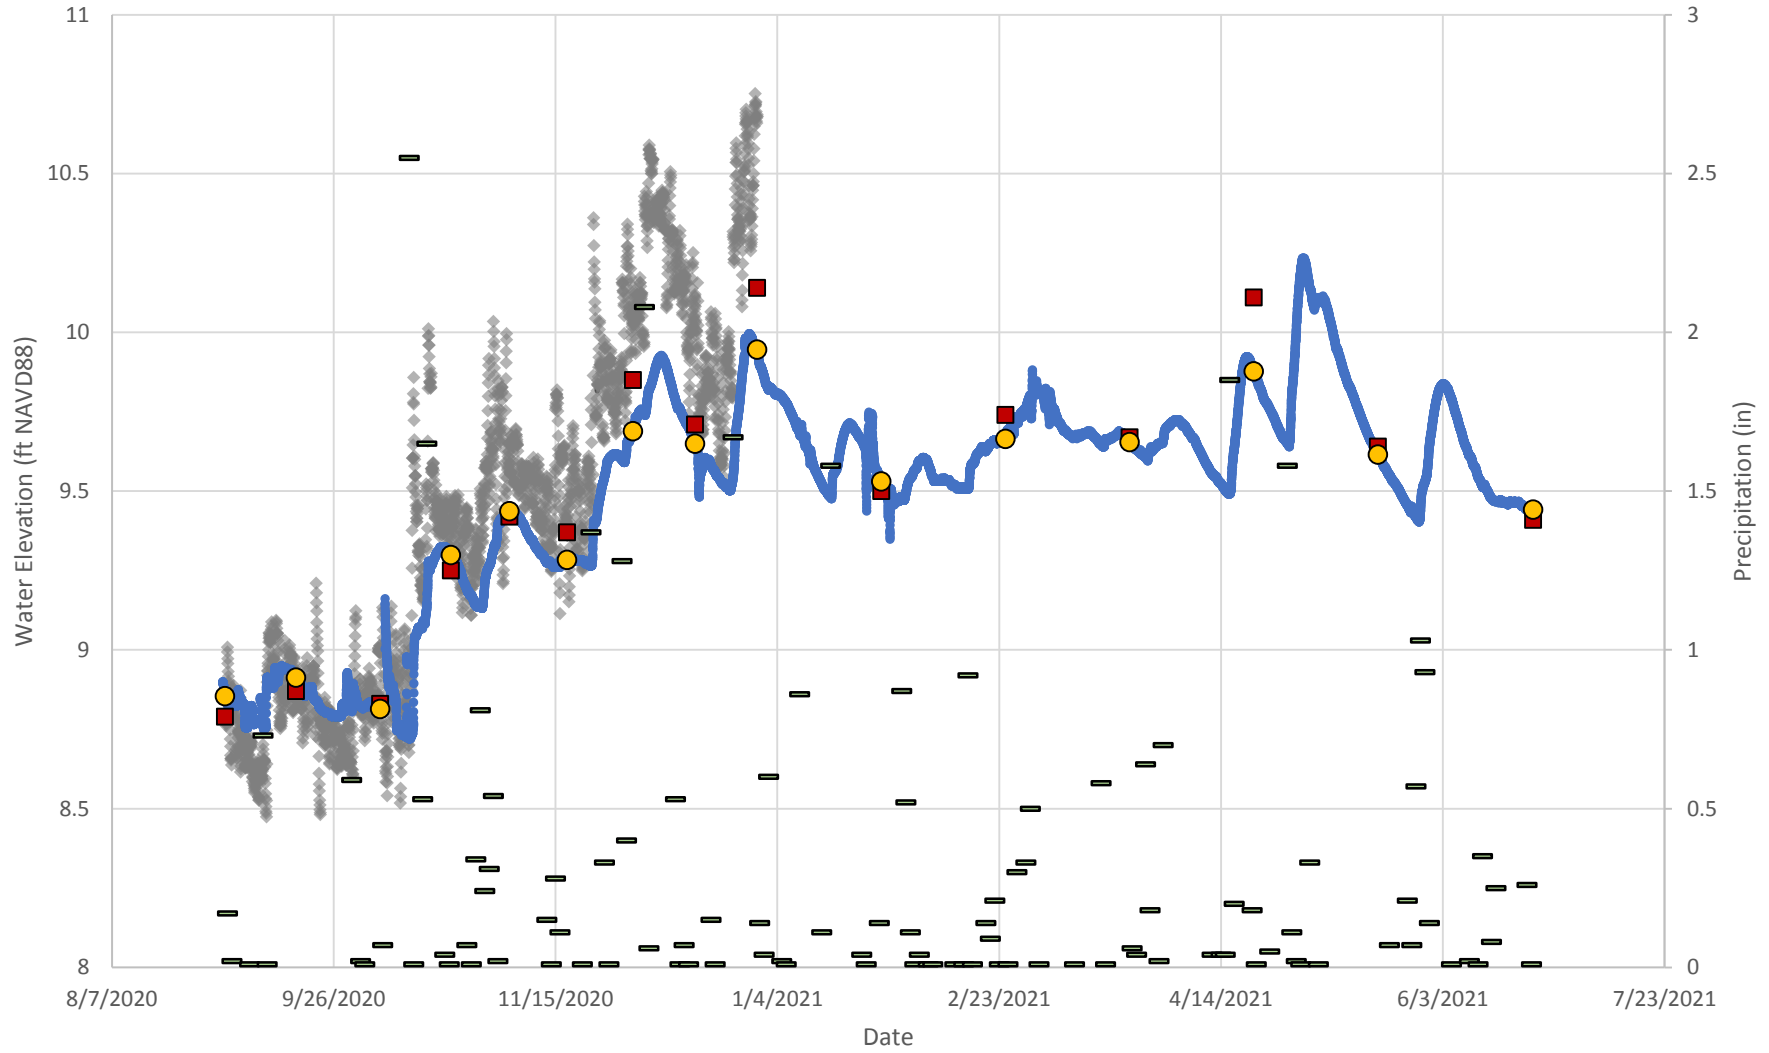
Figure 5. Groundwater Elevation at EBSCO and Adjacent Ipswich River Elevation

A graph depicting all of the Ipswich Mills Dam river water level and HW-2020-1 groundwater level data from September 1, 2020 through June 23, 2021 is included here as Figure 5. Two groundwater level contour maps for the area around the EBSCO facility are presented here as Figures 6 and 7. Figure 6 depicts relatively low water level conditions from October 6, 2020, and Figure 7 depicts relatively high-water level conditions from April 21, 2021.

- The range of observed river elevations immediately above the Ipswich Mills Dam during the September 2020 through June 2021 monitoring period of this study was approximately 8.9 to 10.1 feet, similar to the estimated representative historical range shown in Table 3.

- The range of observed groundwater elevations at well HW-2020-1 (closest well to the southeast corner of the EBSCO building where compressible soils were encountered) during the September 2020 through June 2021 monitoring period of this study was approximately 8.6 to 10.5 feet, similar to though slightly greater than the estimated representative historical range shown in Table 3..

- Water levels for the river and well HW-2020-1 are generally similar. Sometimes there is a slight gradient from groundwater towards the river, and sometimes the opposite, with no clear prevailing pattern evident. This phenomenon can frequently happen in close proximity to dams and impoundments where the more commonly observed in New England hydraulic gradient from the surrounding groundwater towards the river can sometimes be reversed when rising water levels behind the dam exceed the adjacent groundwater levels.

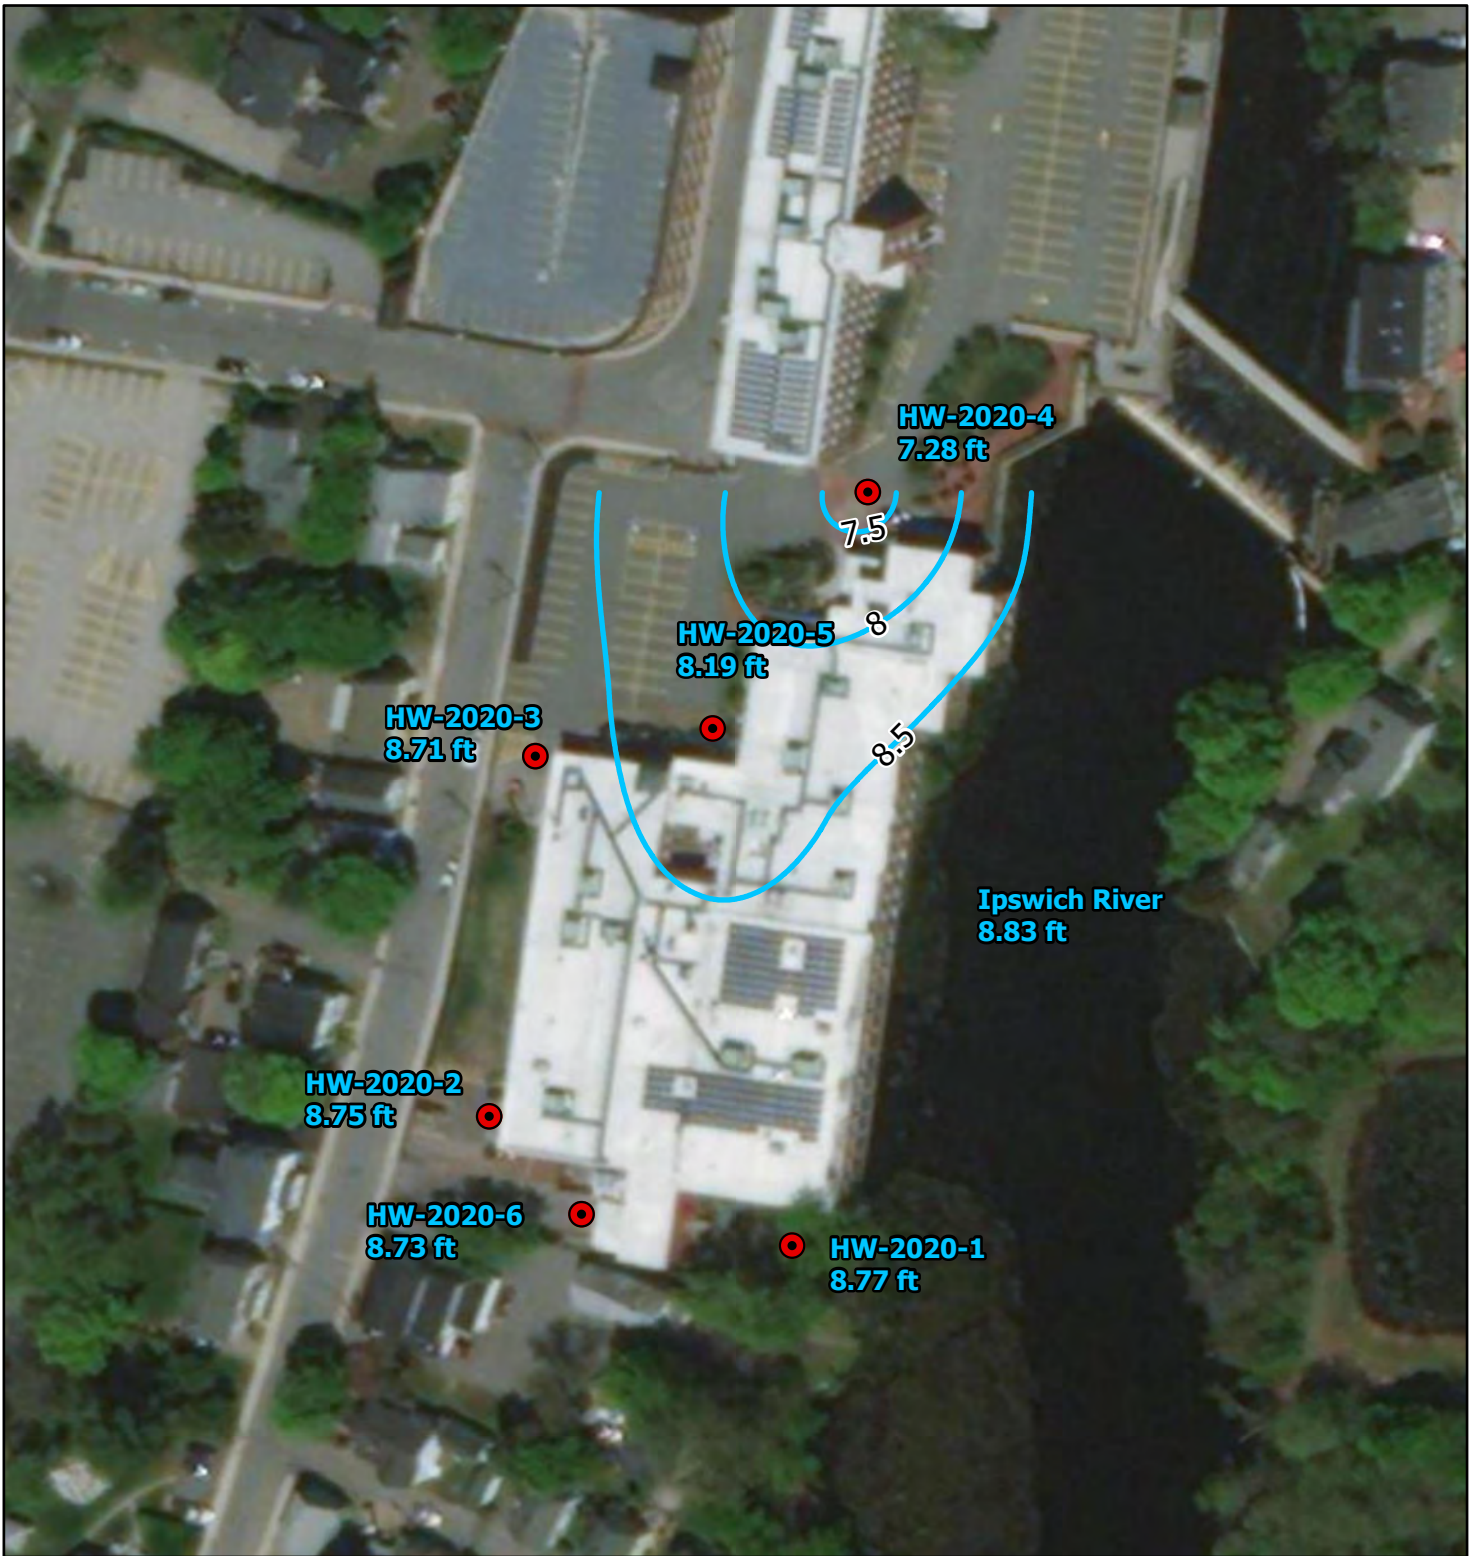
Figure 6

- The two groundwater contour maps for relatively low and relatively high-water level conditions (Figures 5 and 6, respectively) show generally similar patterns of groundwater flow with only the values of each contour changing based on relatively high versus low water level conditions. The pattern of groundwater flow is generally south to north, parallel to the river along the EBSCO facility, instead of trending perpendicular to the river as is more typically seen in New England. The low water point on both contour maps is at well HW-2020-4 at the north end of the EBSCO Facility. This pattern of groundwater flow parallel to and around the impoundment is common in close proximity to dams and impoundments where the elevated river level behind a dam can direct

Water Table Contour Map  
 Low Water Conditions  
 October 6th, 2020  
 Ipswich River, MA

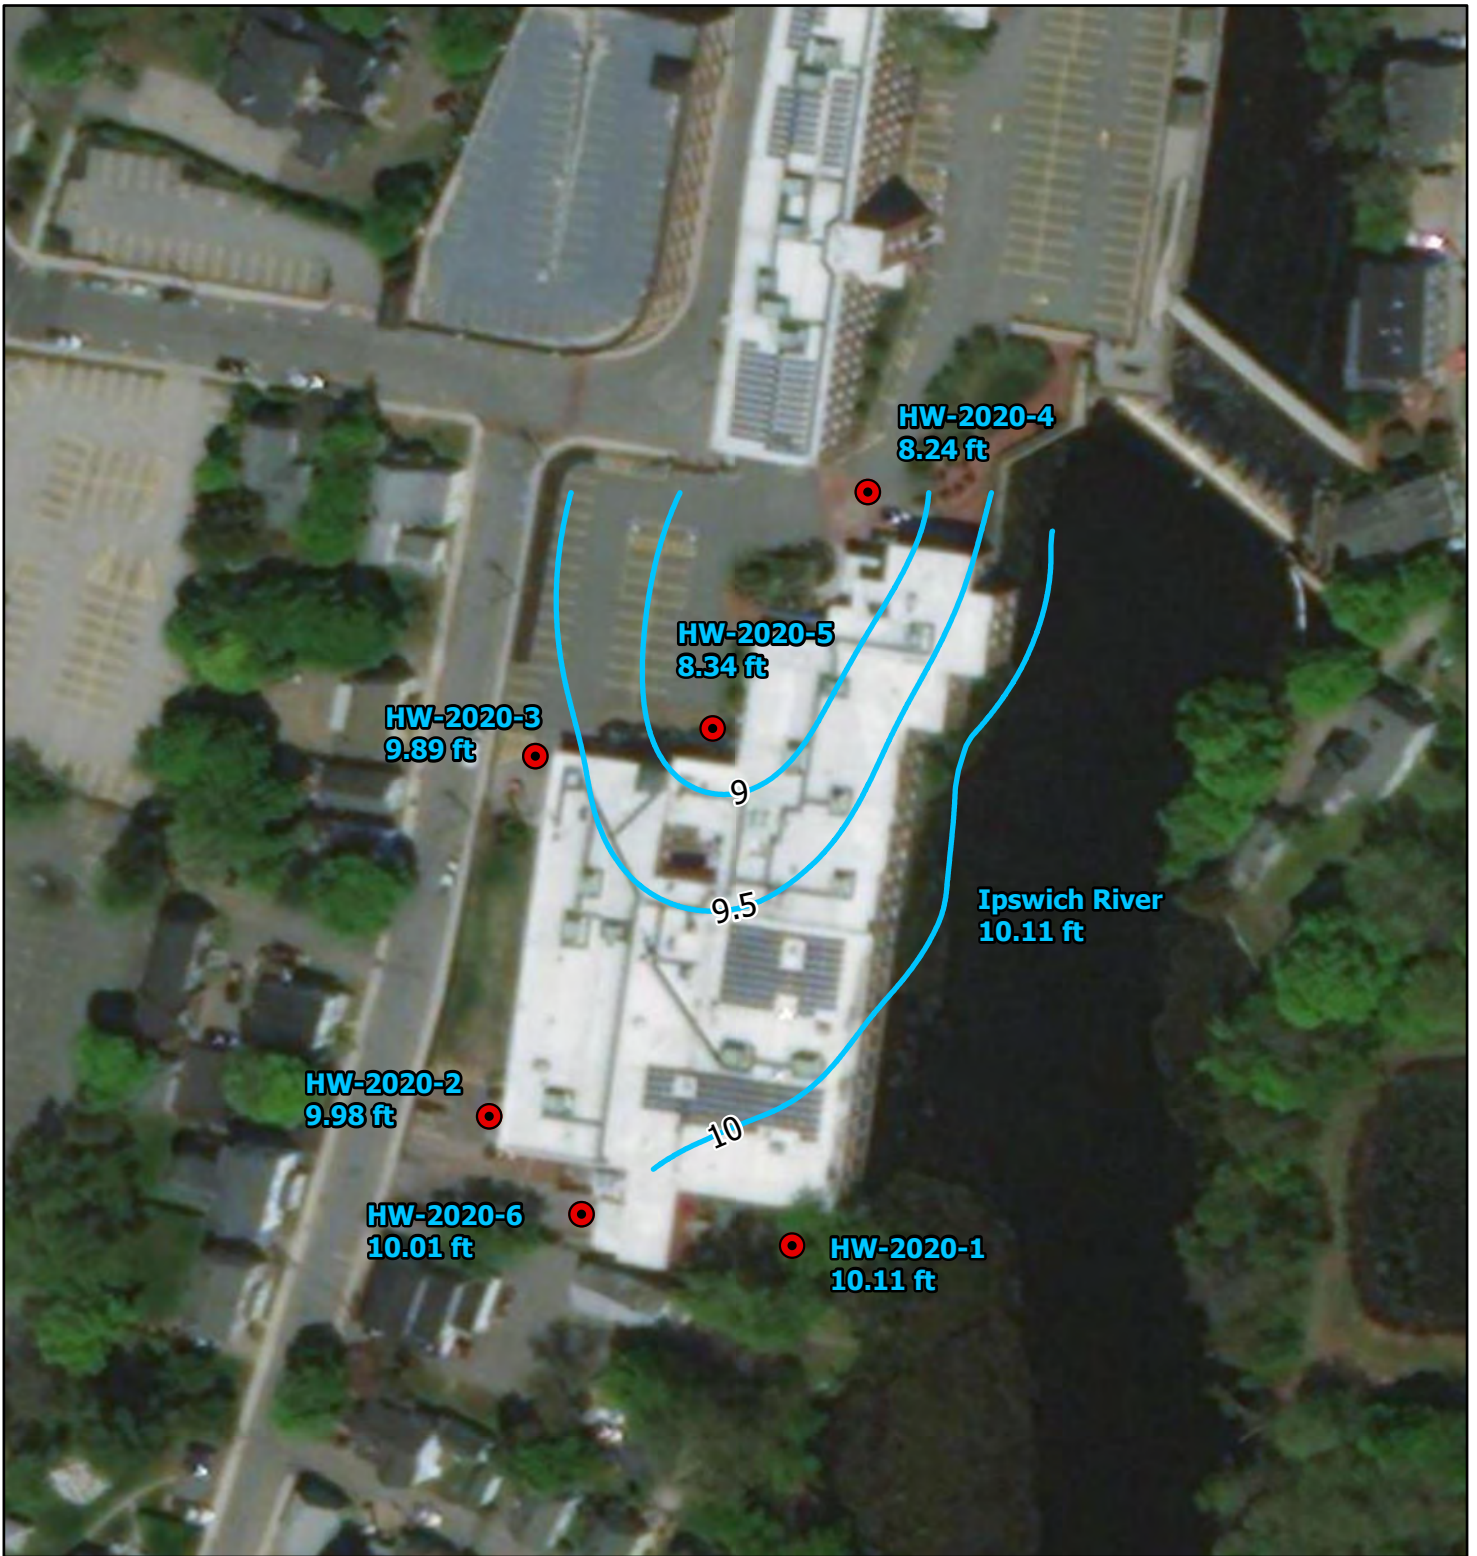
Water Table Contour Map  
High Water Conditions  
April 21st, 2021  
Ipswich River, MA

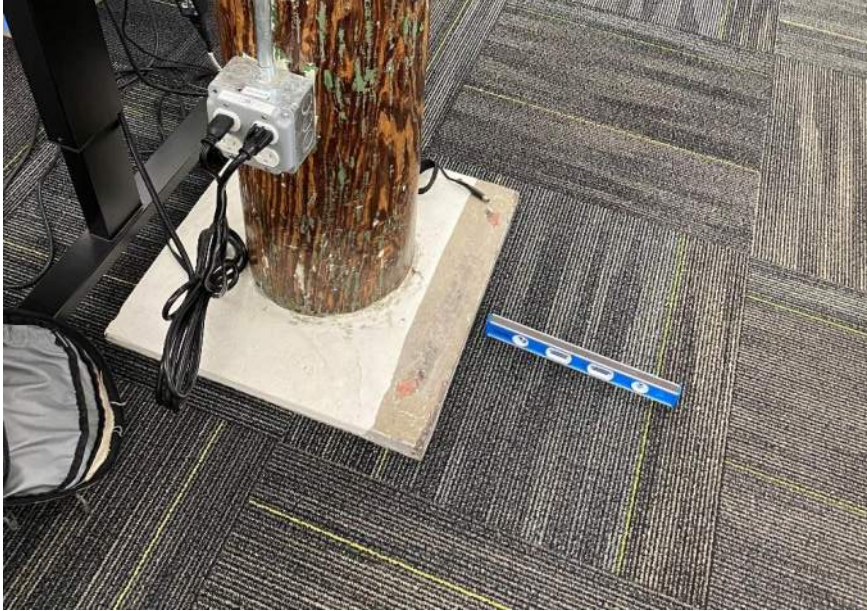
**Photo 4**

- The impact echo results around column “B5” indicate thicker concrete at column lines B and 5, approximately 28 to 35 inches thick, which is consistent with a thickened slab or grade beam foundations aligning with the column lines. RSI indicates that the width of the thickened concrete or grade beams is the same or slightly less than the 21 X 21-inch column pedestal visible above the slab. The column pedestal is approximately 24 to 34 inches deep, similar in width and depth to the grade beams. It is possible that the grade beams and pedestals are integral to each other.

- RSI were able to detect pile or support pier foundations located below the column pedestal. The depth to the bottom of the pile(s) or support pier is 10.7 to 10.8 feet from the top of the pedestal (RSI Report Attachment C - Appendix C Fig. 5). RSI could not determine the composition of the piles or support piers (i.e., wood versus concrete). RSI reports that the grade beams are 24 to 39 inches thick. Based on these results, SGH estimates that the pile or support pier top elevation(s) are located at approximately 8.8 to 9.7 feet and the pile or support pier bottom elevation(s) are located at approximately elevation 0.9 feet.

Pedestal at the base of Column B5.

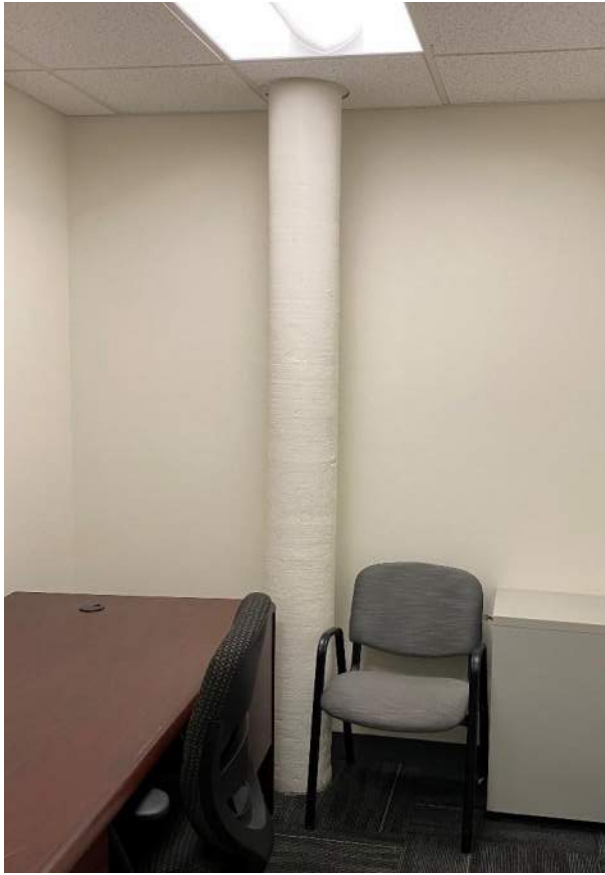
**Photo 6**

- Building 10 columns are 9 in. dia. timber, and the surface is painted white (Photo 6). The finishes on Building 10 columns appear to be plaster or some other cementitious material. We observed one exposed steel column that is 8 in. dia. at Column A'-14 (Photo 7), which is located at the approximate interface between Buildings 10 and 10A.

Example of a typical column in Building 10.

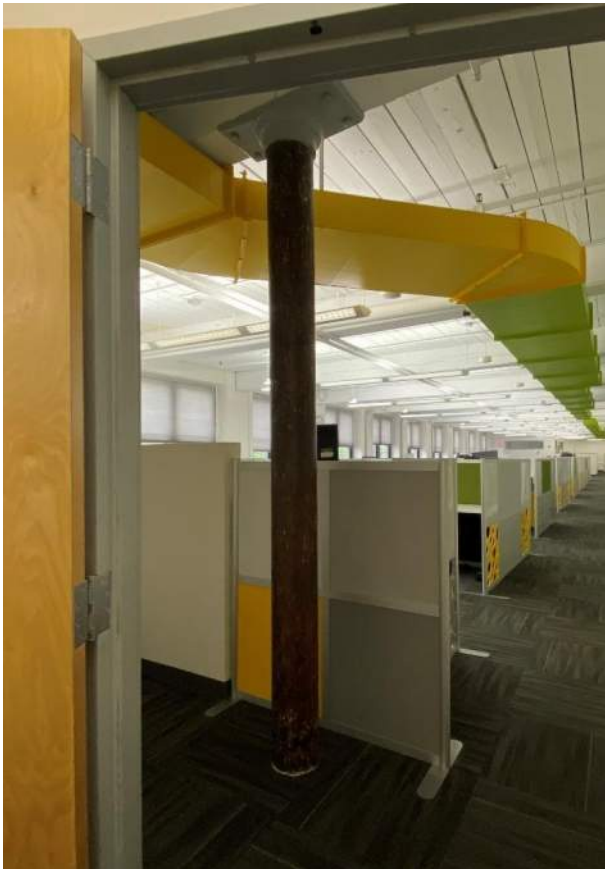
**Photo 7**

Column A'-14, located at the approximate interface between Buildings 10 and 10A.

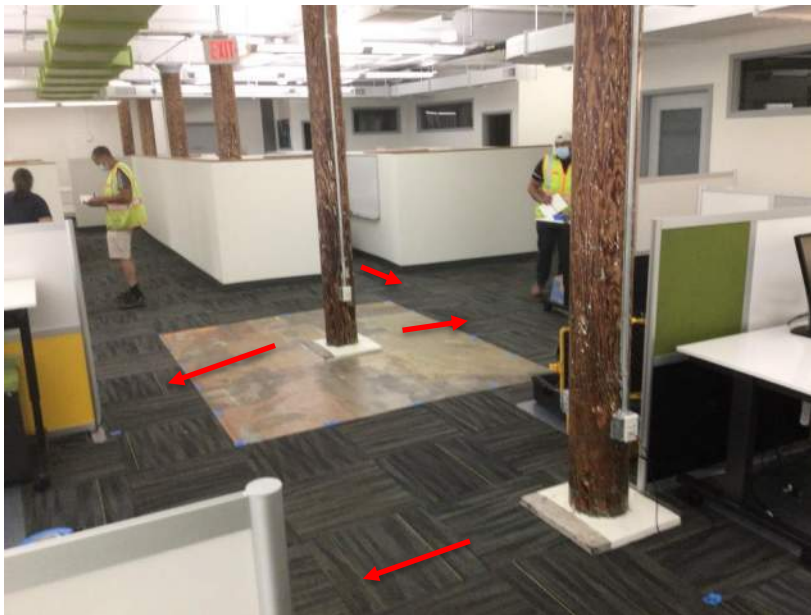
**Photo 8**

- The floor slab slopes downward, away (to the east and west) from the columns at Column Line B (Fig. 1) within Building 10A at the southeast corner of the EBSCO Facility. We measured floor slopes with rises ranging between 3/8 in. and 5/8 in. over a run of 12 in. between Column Lines 2 and 9. The most significant slopes are between Column Lines 3 and 5 (Photos 8 and 9).

We measured floor slopes with rises generally ranging between 3/8 in. and 5/8 in. over a run of 12 in. between Column Lines 2 and 9. The most significant slopes are between Column Lines 3 and 5, up to 1 in. over 12 in. near Column B4.

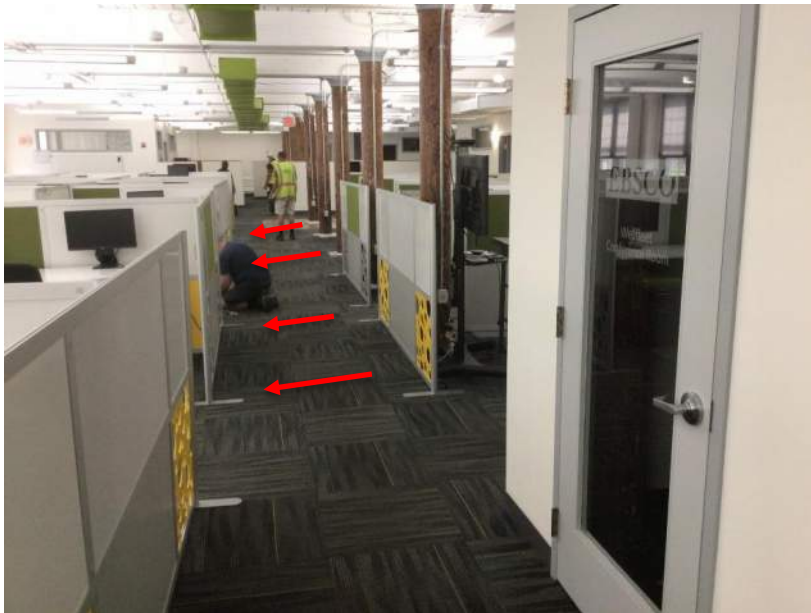
**Photo 9**

We measured floor slopes with rises generally ranging between 3/8 in. and 5/8 in. over a run of 12 in. between Column Lines 2 and 9. The most significant slopes are between Column Lines 3 and 5, up to 1 in. over 12 in. near Column B4.

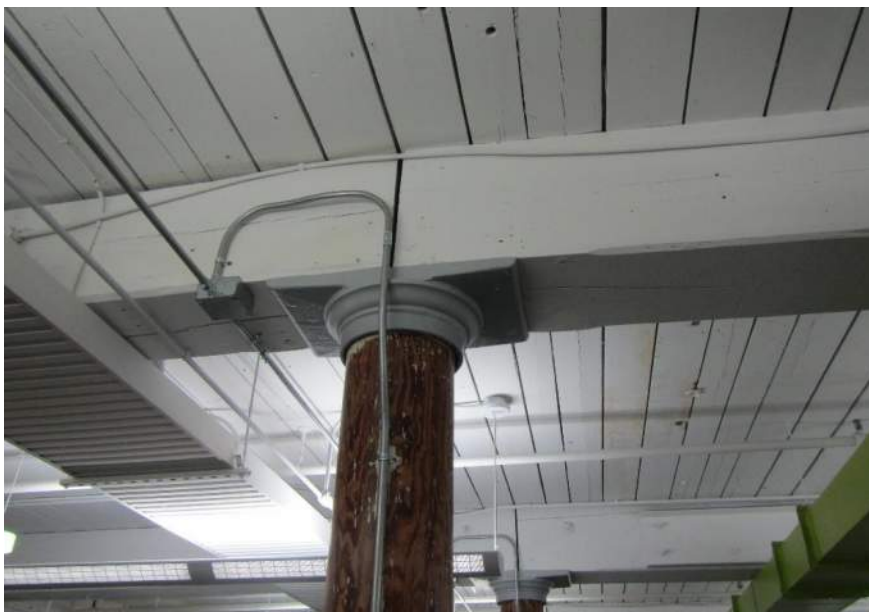
**Photo 10**

- Several beams spanning between Column Lines A and B and Column Lines B and C appear to have rotated, as indicated by a gap between the beams visible above Column Line B (Photos 10, 11, 12, and 13 show beams above Column Line B at Column Lines 4, 5, 6, and 7 respectively).

Gap between beams above Column B4. View looking north.

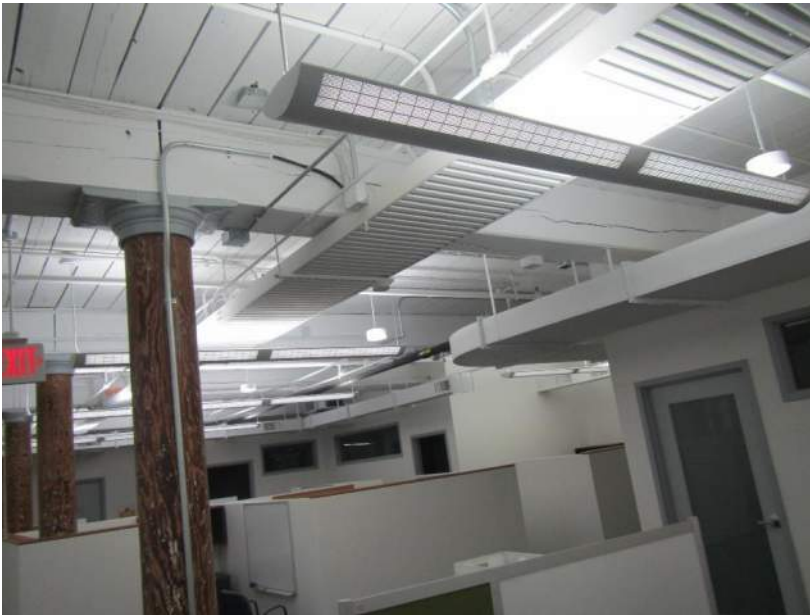
**Photo 11**

Gap between beams above column B5, view looking south.

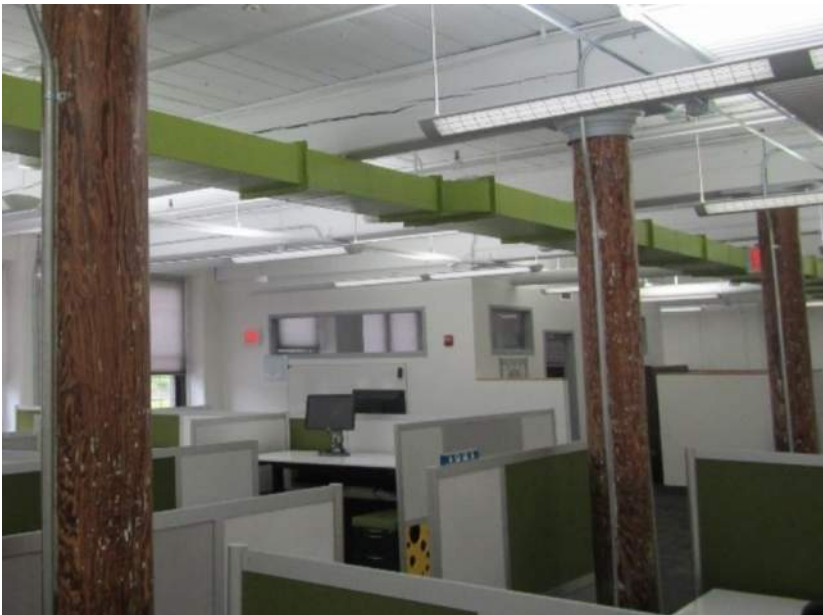
**Photo 12**

Gap between beams above Column B6, view looking south.

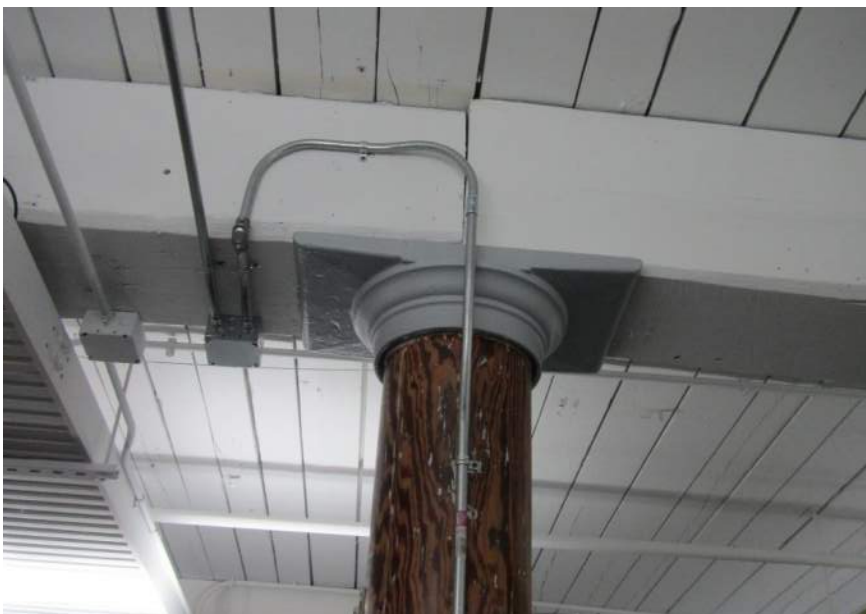
**Photo 13**

Gap between beams above Column B7.

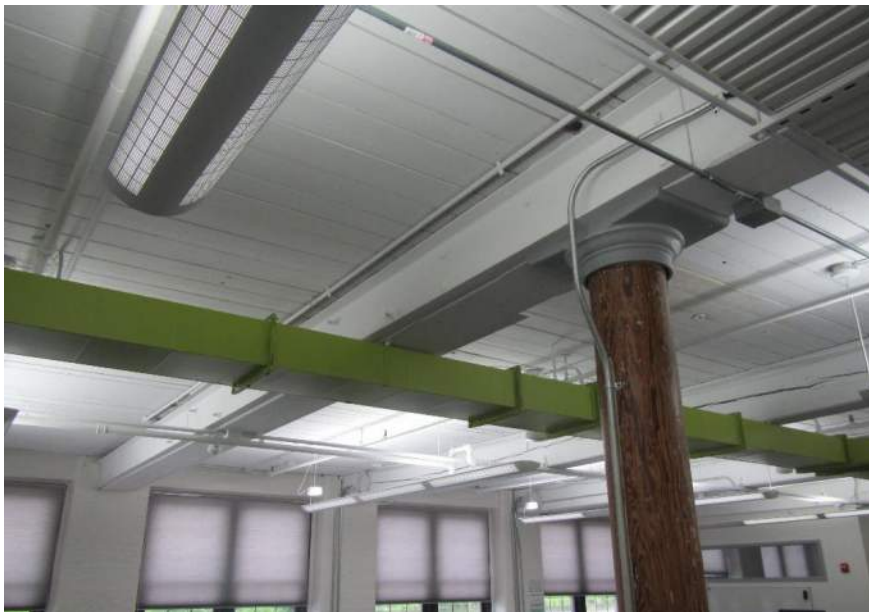
**Photo 16**

- The timber beams are strengthened at Column Lines 4 and 7 (Photo 16). 7 in. deep steel channels with 3 in. wide flanges have been sistered to the beams spanning between Column Lines A and B (two channels at Column Line 7, one channel at Column Line 4).

The timber beam at Column Line 7 spanning between Column Lines A and B has been strengthened with steel channels sistered to the beam.

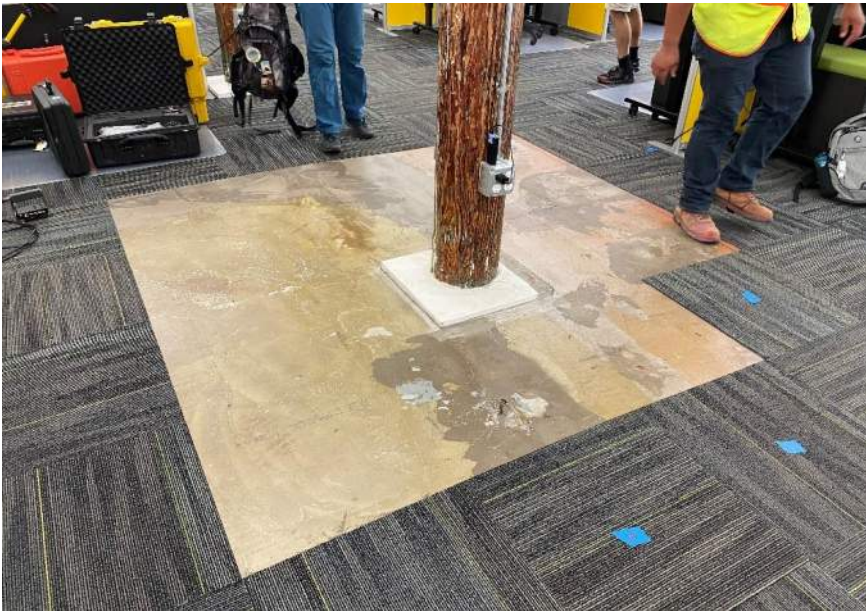
**Photo 17**

- The ground-floor slab is covered by carpet finishes. We temporarily removed carpet tiles to expose the concrete floor slab around Column B5 to provide access for RSI to perform impact echo testing (Photo 17). The floor slab has been covered with a patching or leveling compound material, and there were no cracks visible where the floor is sloped. We observed a shallow surface spall and crack in the patch material southwest of Column B5 (Photo 18). This crack may be in line with a buried foundation element; however, the patching material conceals most of area where we would expect cracking. Note that in general, we did not observe construction joints or cracks through the slab that could potentially indicate the locations of foundation elements below the slab.

We temporarily removed carpet tiles to expose the concrete floor slab around Column B5 to provide access for RSI to perform impact echo testing. The floor slab has been covered with a patching or leveling compound material, and there were no cracks visible where the floor is sloped.

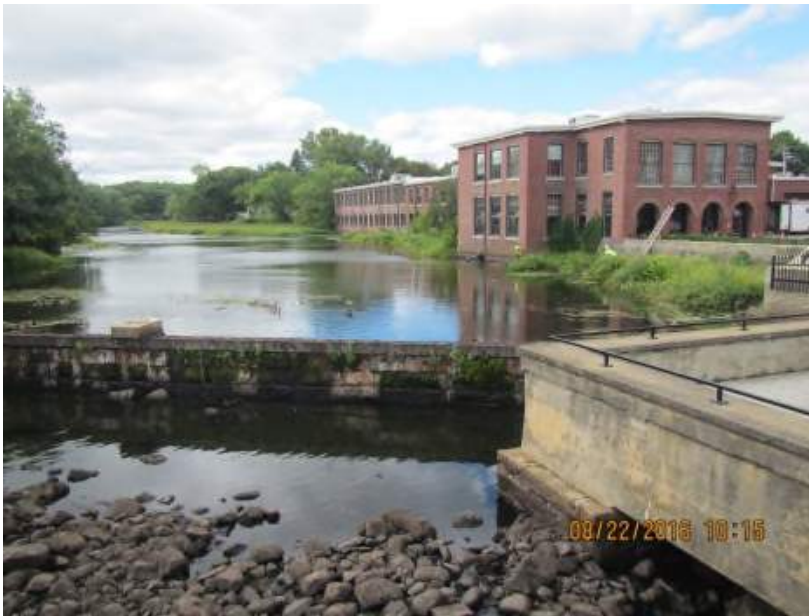
**Photo 2**

View of EBSCO building on 24 August after the temporary impoundment drawdown.

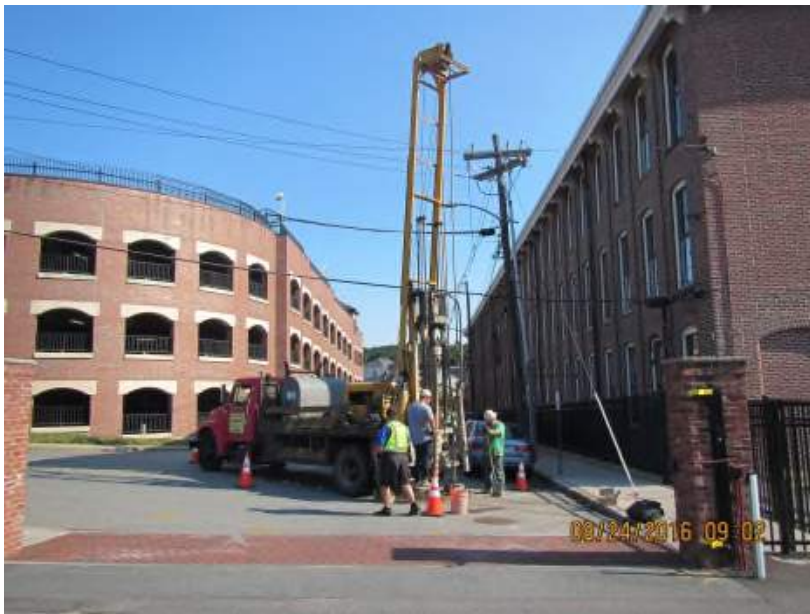
Soil test boring locations are shown in Fig. 1. Two soil test borings were drilled on Saltonstall Street (Photo 8) and Estes Street, adjacent to the EBSCO campus; and one soil test boring was drilled in the gravel driveway located on the town right of way access to the dam adjacent to the private residence located at 69 South Main Street. A representative from SGH was present throughout the field work to observe drilling, assist in obtaining samples, and prepare a descriptive log of each test boring. The sampling intervals, soil descriptions, Standard Penetration Test (SPT) blowcounts, and other pertinent field data are summarized in the individual soil boring logs included in Appendix D.

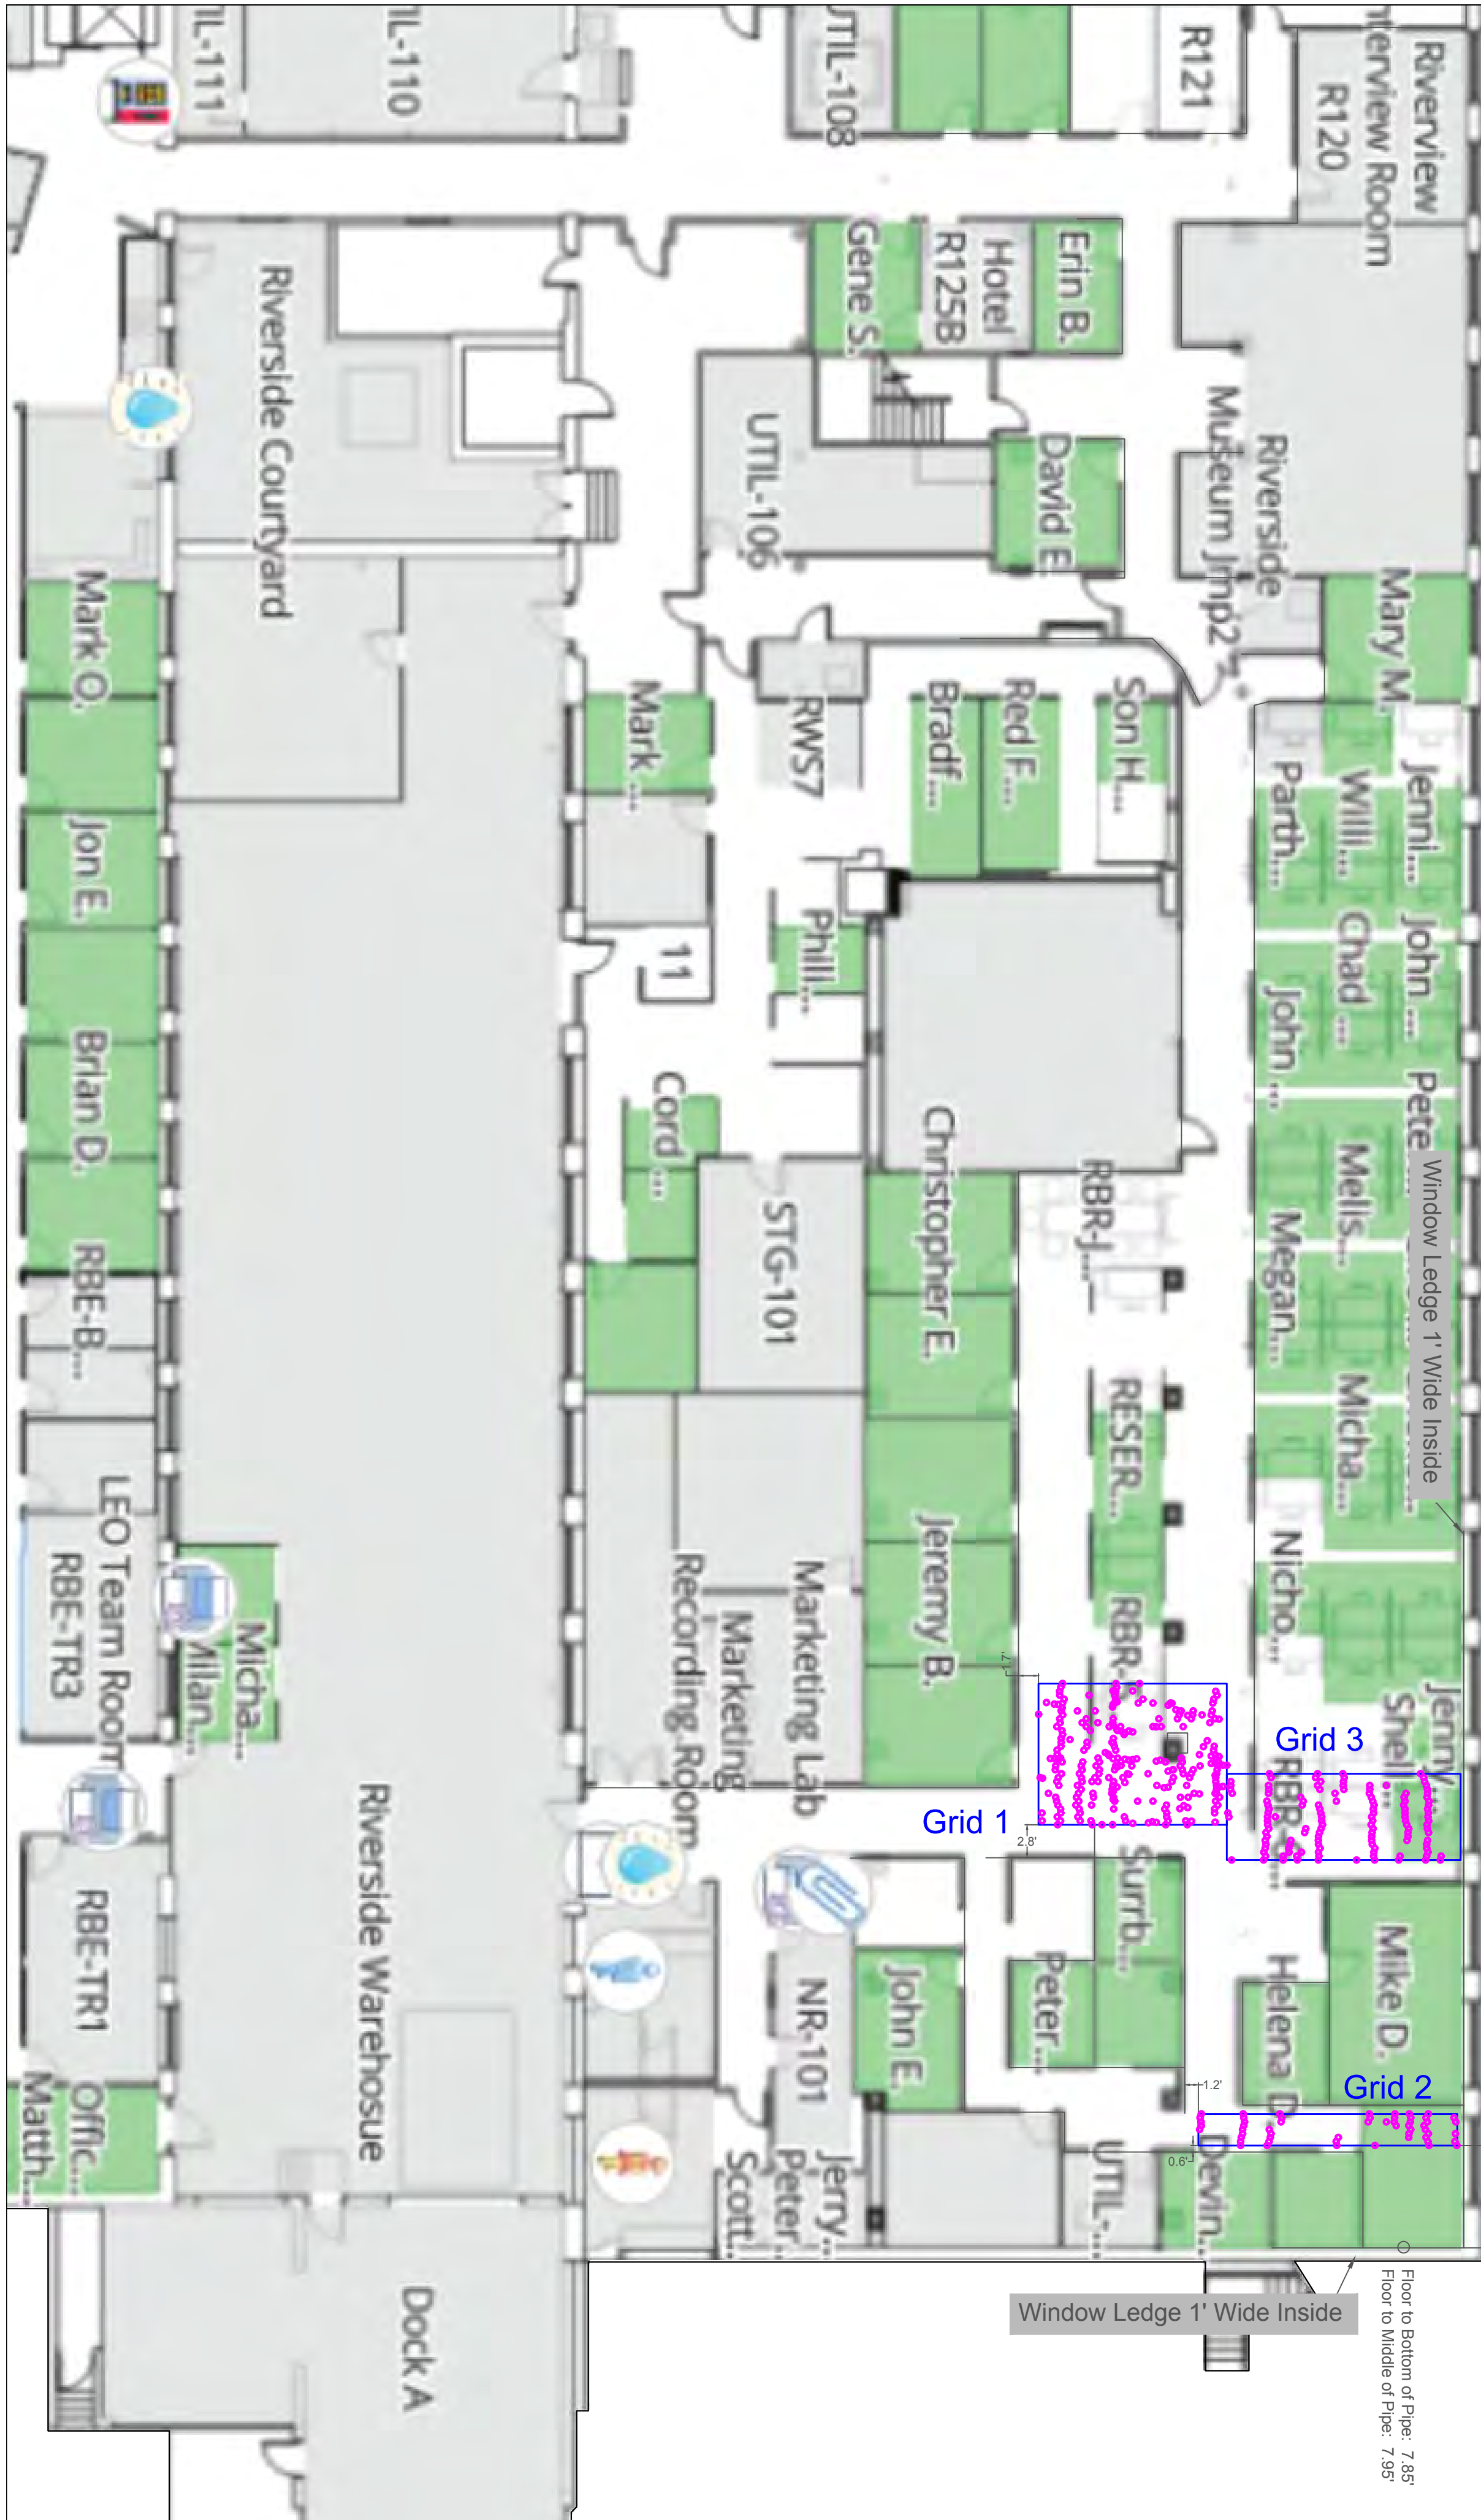
- The alignment of pile columns within the area surveyed appears to be north-south.
- Along the pile column, the piles appear as clusters or as individual piles.
- The distance between pile columns ranges from approximately 2.5 to 4 feet.
- The amplitude of reflections from the top of piles is variable, suggesting different pile conditions
- In general, the depths to the apparent top of piles are variable, ranging from 2.5 to 4.5 feet below ground level (elevation ranging from 7.15 to 9.15 feet).
- Although difficult to assess, the vertical pile lengths may extend between 12 to 15 feet below ground surface.
- The pile column closest to the exterior wall in Grid 3 is located approximately 4.5 feet from the outer wall.

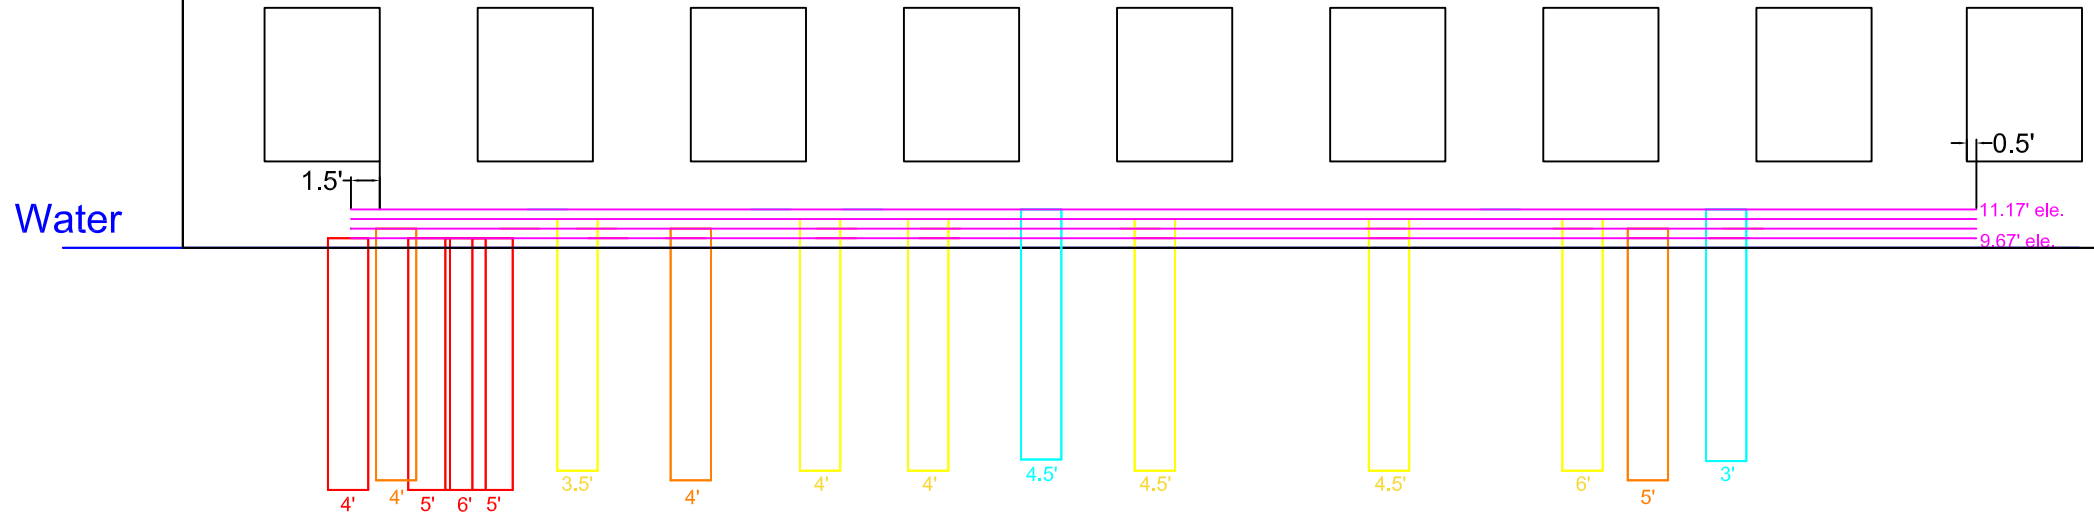
Schematic Sketch of Pile Locations  
Outer Foundation Wall GPR Survey  
EBSCO Building East Wall  
Ipswich River  
Ipswich, MA

350-MHz records were examined in sequence from lowest to highest elevation. The positions of interpreted piles in terms of distance behind the wall were noted and mapped using AutoCAD. With the exception of lowest-elevation traverse results, only anomalies that persisted across multiple traverses were interpreted as potential piles.

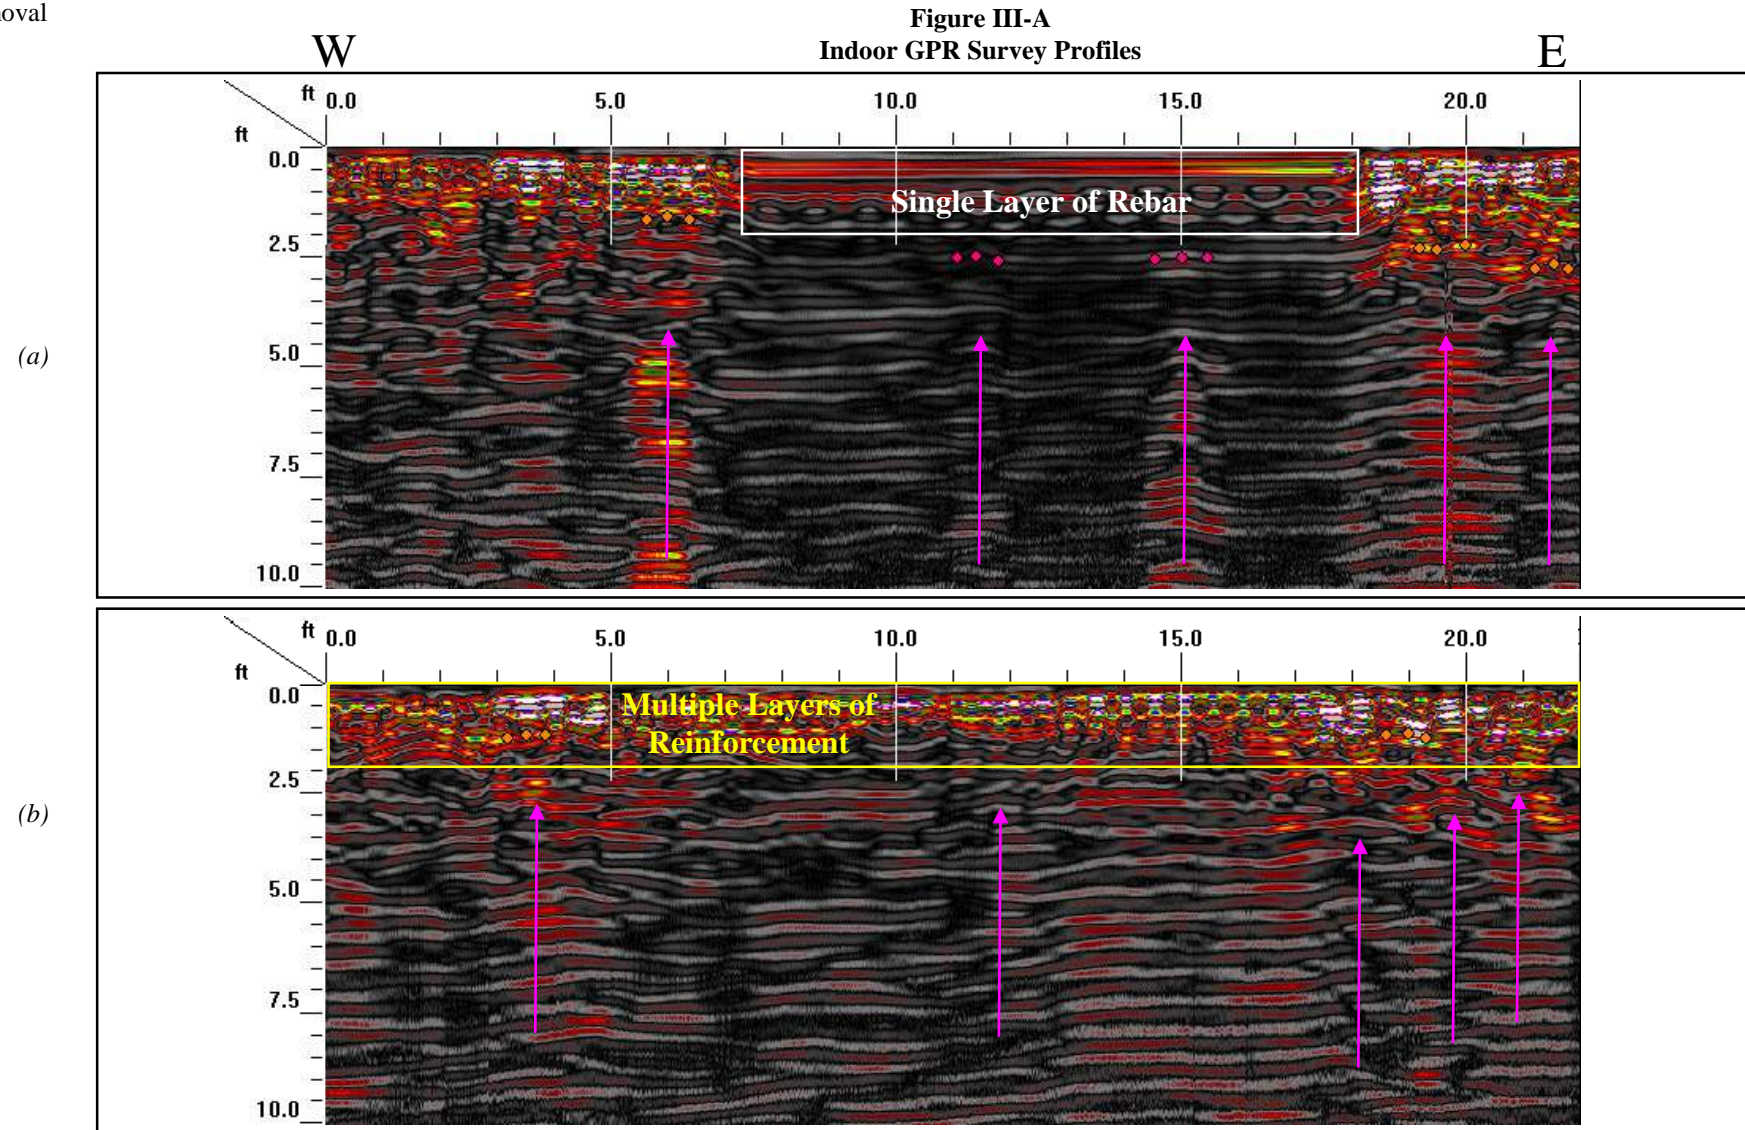
*Figure III-A.* Piles identified in records from GPR Grid 2, collected in the southeastern section of the EBSCO building from west to east (toward windows). Concrete floor slab reinforcement varied throughout the surveyed areas. Identification of potential piles was straight-forward in (a) areas where the slab reinforcement consisted of a single layer of rebar (white box). In areas with multiple layers of slab reinforcement, an example of which is highlighted with a yellow box in (b), pile identification required additional effort with data processing and interpretation. Pink arrows indicate the “ringing” signature of potential piles, while dots indicate the interpreted tops of piles where clear.
