## MEMORANDUM

**To:** Kristopher Houle, DER  
**From:** Neal Price  
**Date:** June 30, 2021  
**Re:** Ipswich Mills Dam Removal – Summary of Spring 2021 Project Work: EBSCO Geophysical Study, EBSCO-Area Hydrologic Evaluation, and In-River Sediment Properties

The Horsley Witten Group, Inc. (HW) is pleased to submit to the Massachusetts Division of Ecological Restoration (DER) the following memorandum summarizing recent work completed in the spring of 2021 on the Ipswich Mills Dam Removal Feasibility Project (the Project). These work items included:

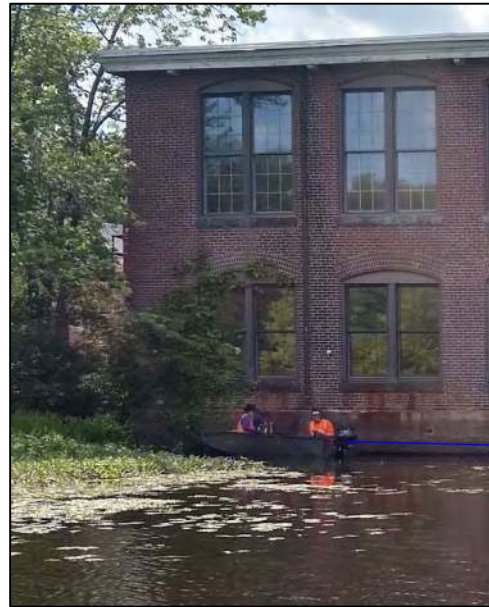
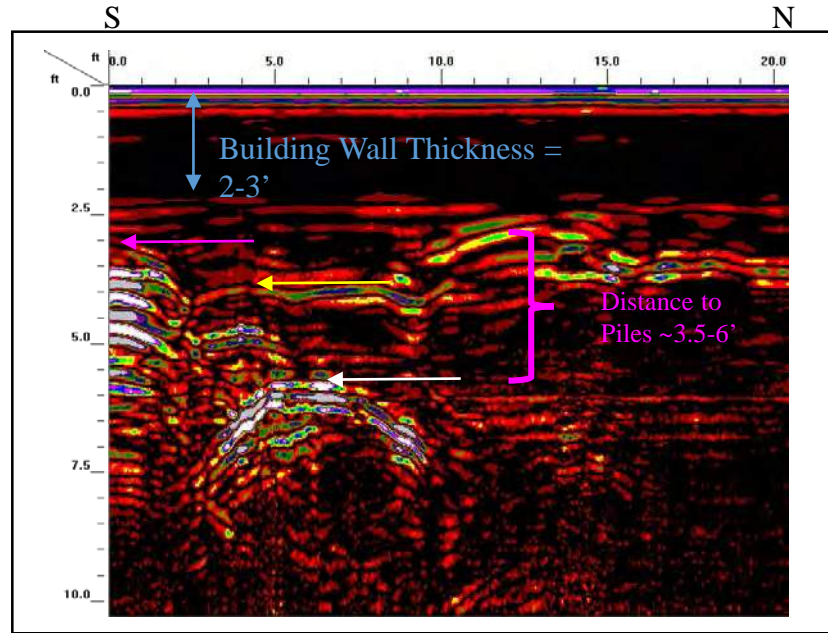
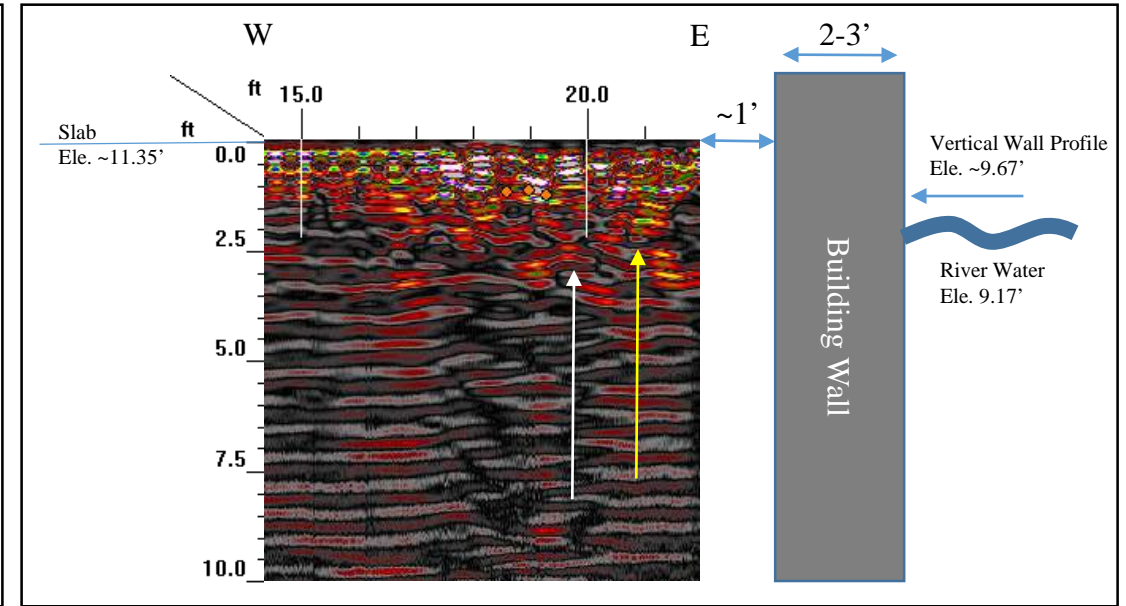
Figure III-B  
Vertical Wall GPR Survey Profile

- Depth of penetration in the vertical wall survey was influenced by the presence or absence of vertical rebar in the wall, which was most common in the southernmost 50 feet of each traverse and was sporadically observed in northern sections, and wall moisture content. Moisture content increased from south to north, correlating with the erosion of the concrete matrix noted along the wall.
- Elevation of the top of observable pile structures ranges from 9.67 feet to above 11.17 feet as shown in Plate III-C. The top of pile structures may include structural components on top of the pile and may not, therefore, represent the top of the pile. This was deduced by noting where the vertical features no longer appear in records collected at increasing elevation. The termination point of pile structures observed in the topmost

- The pile pattern observed in the indoor and vertical wall survey areas may not extend to the rest of the building areas.
- All vertical wall records were collected above the water, so these targets are already partially exposed to aerobic conditions that occur as a result of river level changes.
- Reflection amplitude is generally an indication of pile condition. Bright spots (high-amplitude reflections) at the tops of piles, as observed in vertical wall records and in certain parts of interior grid records, may indicate unstable conditions due to air gaps or conductive aerobic bacteria, suggesting rot.

Figure III-B. Additional GPR data were collected along the exterior of the EBSCO building by boat, with approximate traverse location shown as blue line (a). Traverse collected from south to north along the boat-accessible portion of the building at an elevation of 9.67 feet shows evidence of wood piles, indicated with pink, yellow, and white arrows in (b). Note that distance behind the vertical face of the wall is expressed along the y-axis of (b) and depths expressed along the y-axis of (c) are converted from two-way travel times and are dependent on the water content in the concrete, which varied within the survey area. As such, these distance and depth estimates are approximate. Features indicated with yellow and white arrows in (b) are also identified in (c), a reproduction of a portion of Figure G-1(b) showing the lower-confidence interpreted pile locations.

If a more concerted effort to map piles from vertical wall imaging is desired, we recommend repeating the survey with tighter distance control via survey wheel, establishment of a grid using chalk snap lines or other marking devices, and measurement of locations for multiple building features (e.g., southern edge of building, window ledges and intervening brick columns). If the water level is naturally lower at the time of a new survey, or if the water level can be lowered by dam control, additional traverses at lower elevations would image lower portions of the piles.

Repeating the survey farther to the north along the building wall can confirm the absence or presence of piles where the compressible soils layer is thinner, as revealed by the MASW survey.

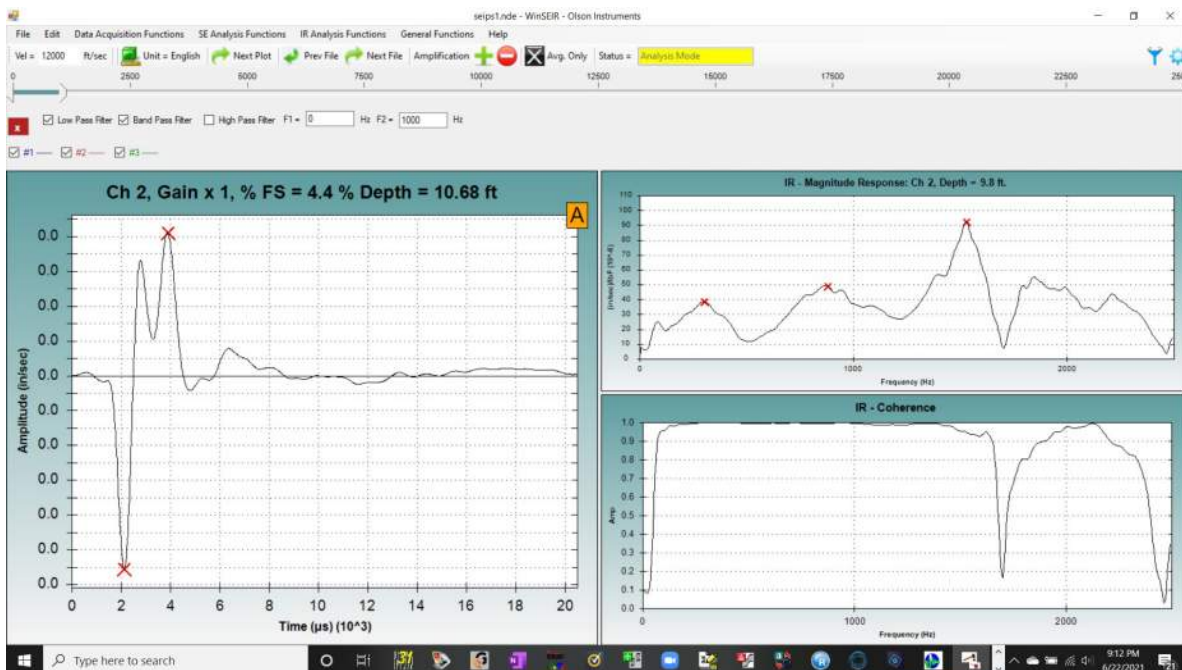
The purpose of conducting SEIR in proximity of the column and on top of the pedestal was to determine how the column is supported. Based on IE data, we believe that the pedestal is about 24 to 34 inches in thickness, and that there are grade beams tied into the pedestal. What was unknown prior to the SEIR survey was if there was a timber pile (or timber piles) beneath the pedestal. Three measurements were made at three locations, approximately 120 degrees from each other, around the column. The data shows that at each location where the measurement was taken, the pedestal is in structural contact with a pile. We can not tell whether that there are three piles or one large pile, just that the pedestal is in structural contact with it/them. Figure 5 shows that the depth to the bottom of the wood timber pile is about 10.7 to 10.8 feet, based upon the arrival time of the highest positive peak. Below is a representative SEIR record from the SEIR survey at column 5.

Typically, the polarity of the highest peak is negative, assuming that the wave is traveling from a higher impedance material to a lower impedance material. The positive peak, shown below, suggests that the wood pile timber is imbedded in a higher impedance material at about 10.7 feet. Based on HGI's August 2020 report and from SGH personal communications, we believe that this pile sits on top of a compact glacial till.

The Impulse Response data, plotted as a function of frequency, confirms the approximate 10 foot depth of the timber pile. If anything, it slightly under-predicts the pile depth when compared to the amplitude plot in the time-domain. In the frequency domain, we observe resonant frequencies at 300 Hz, 900 Hz, and at 1500 MHz. The first peak at 300 Hz is half the difference of frequencies between 900 Hz and 300 Hz, and 1500 Hz and 900 Hz, also suggesting that the timber is in structural contact with a higher impedance material. The resonance frequency is also what determines the timber depth.

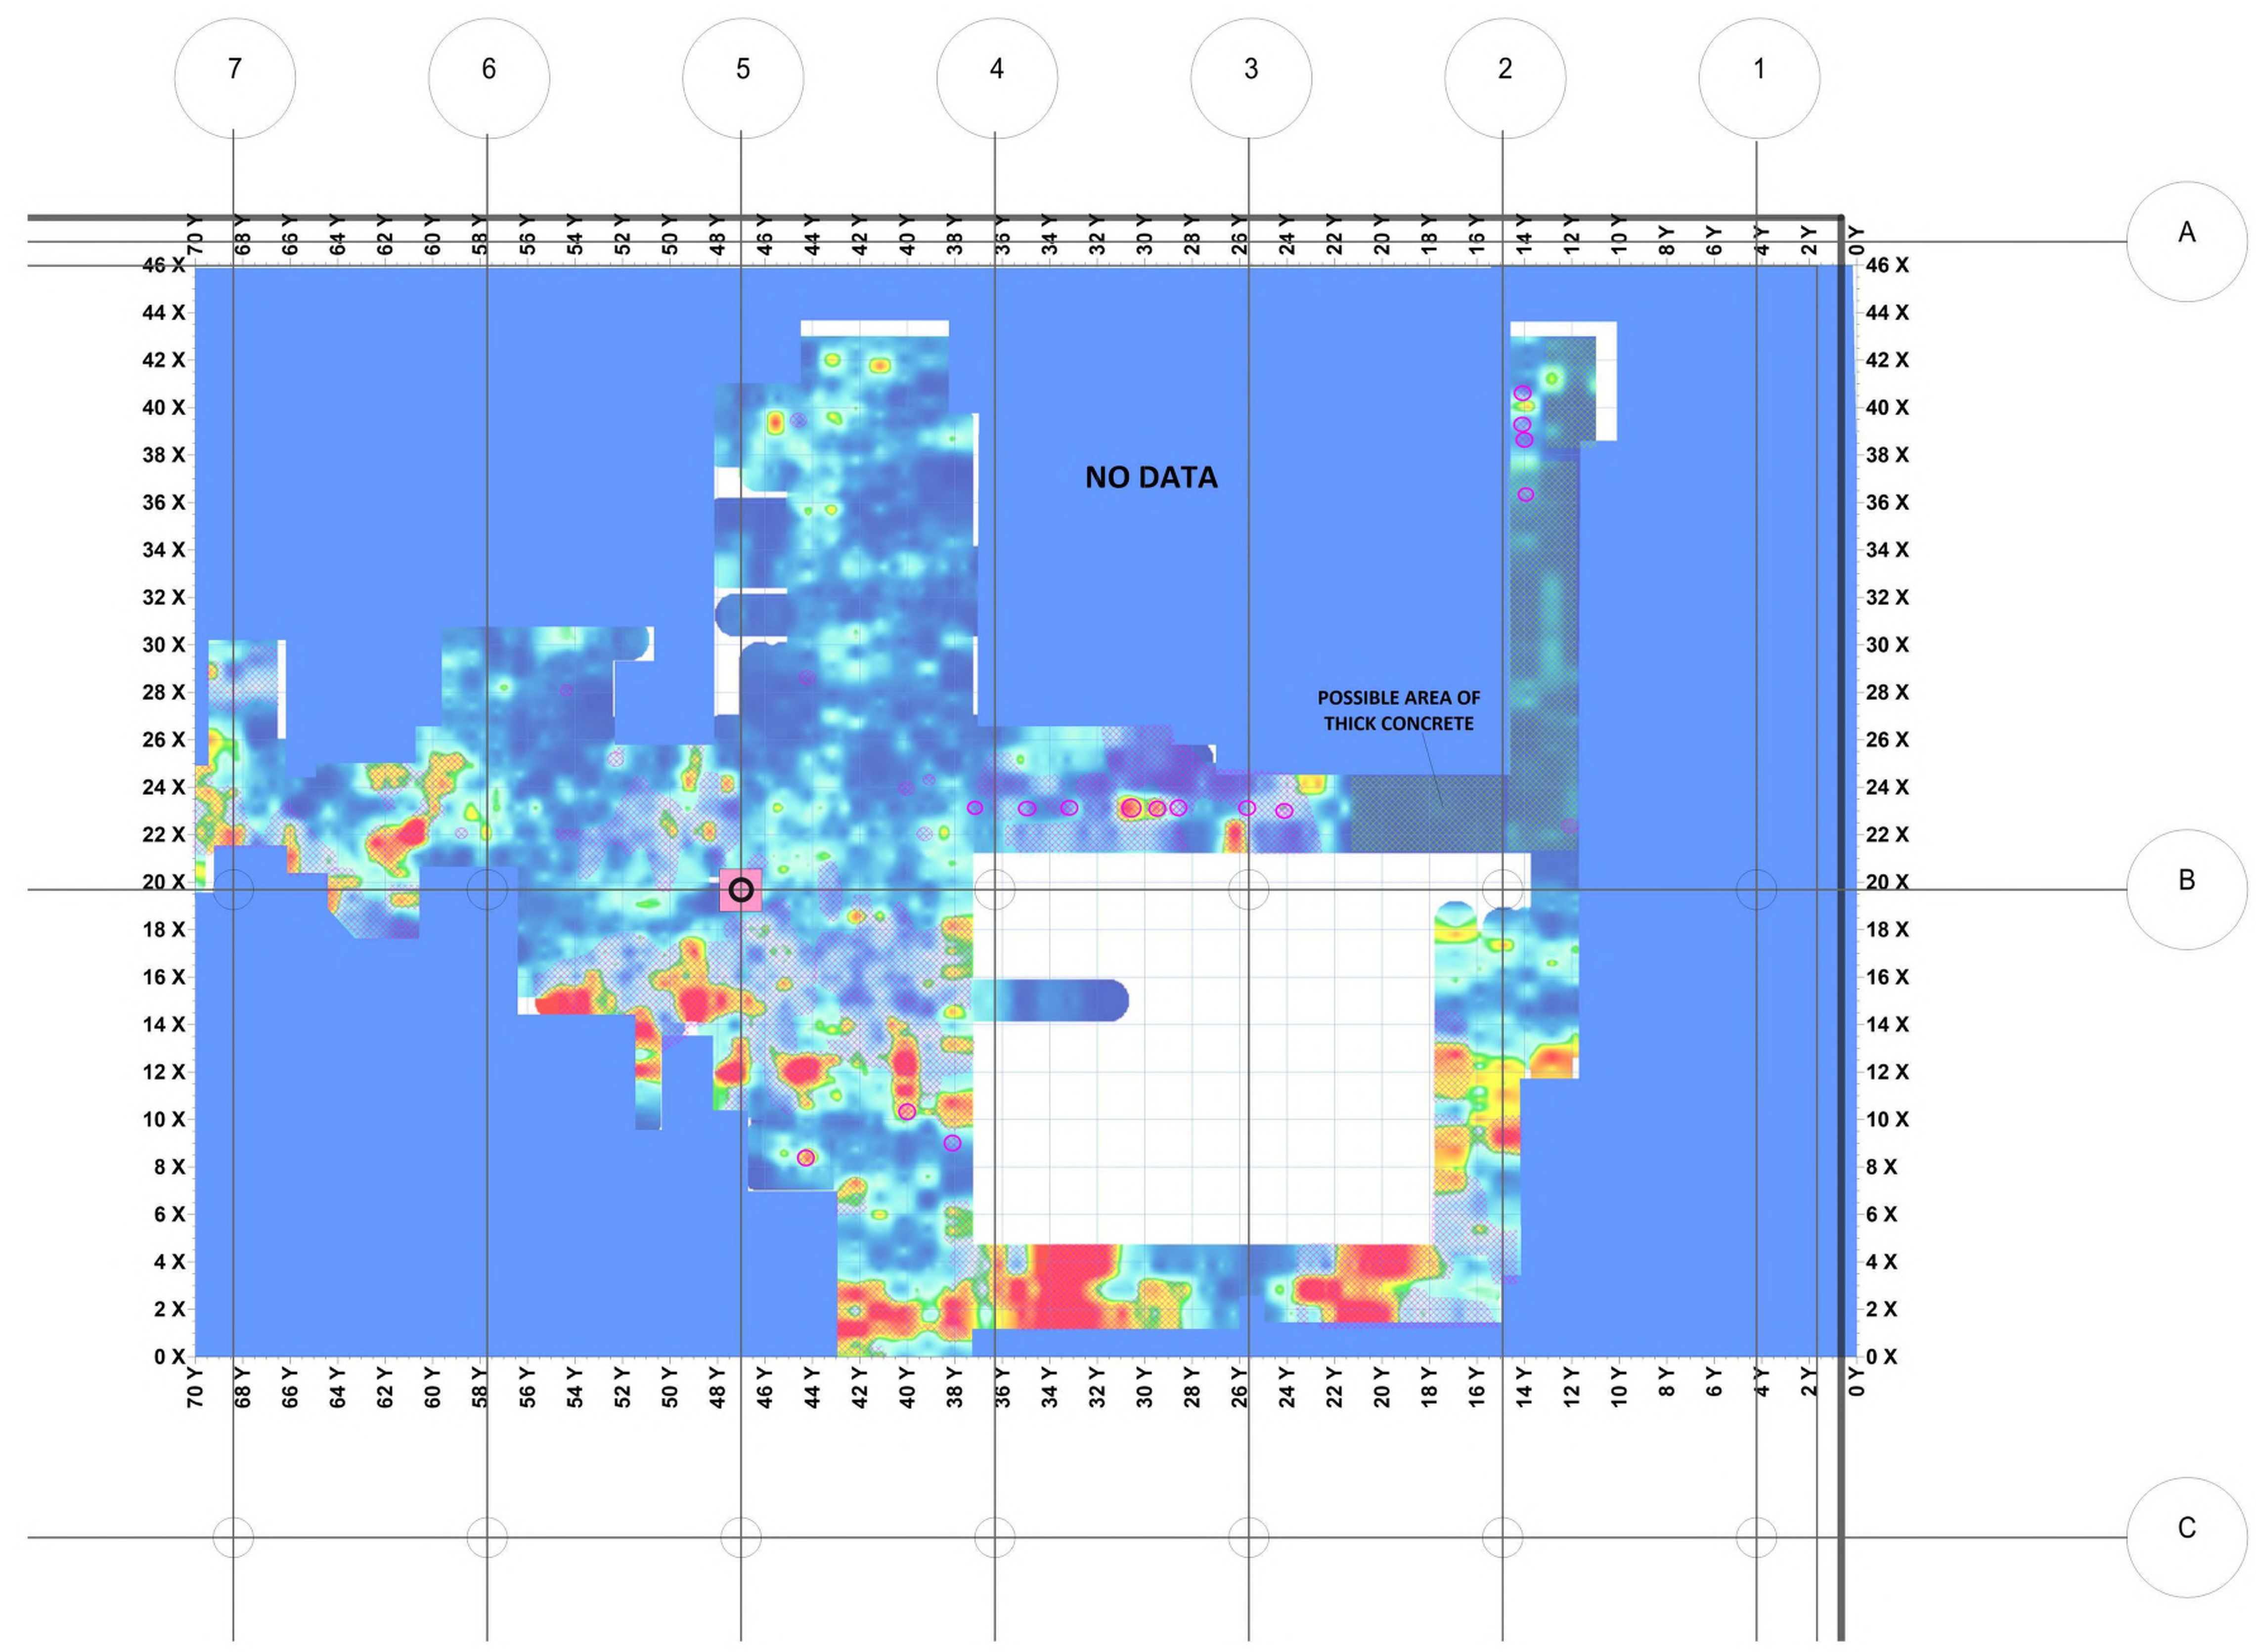
**FIGURE 7H**  
**REPRESENTATIVE DEPTH SLICE IMAGE OF**  
**500 MHz GPR DATA**  
**TO IDENTIFY TOP OF TIMBER PILES**  
**EBSCO**  
**10 ESTES STREET**  
**IPSWICH, MASSACHUSETTS**  
 Prepared for  
**SIMPSON GUMPERTZ & HEGER**  
 JUNE 2021

**DEPTH: 2.2 ft. - 2.5 ft.**

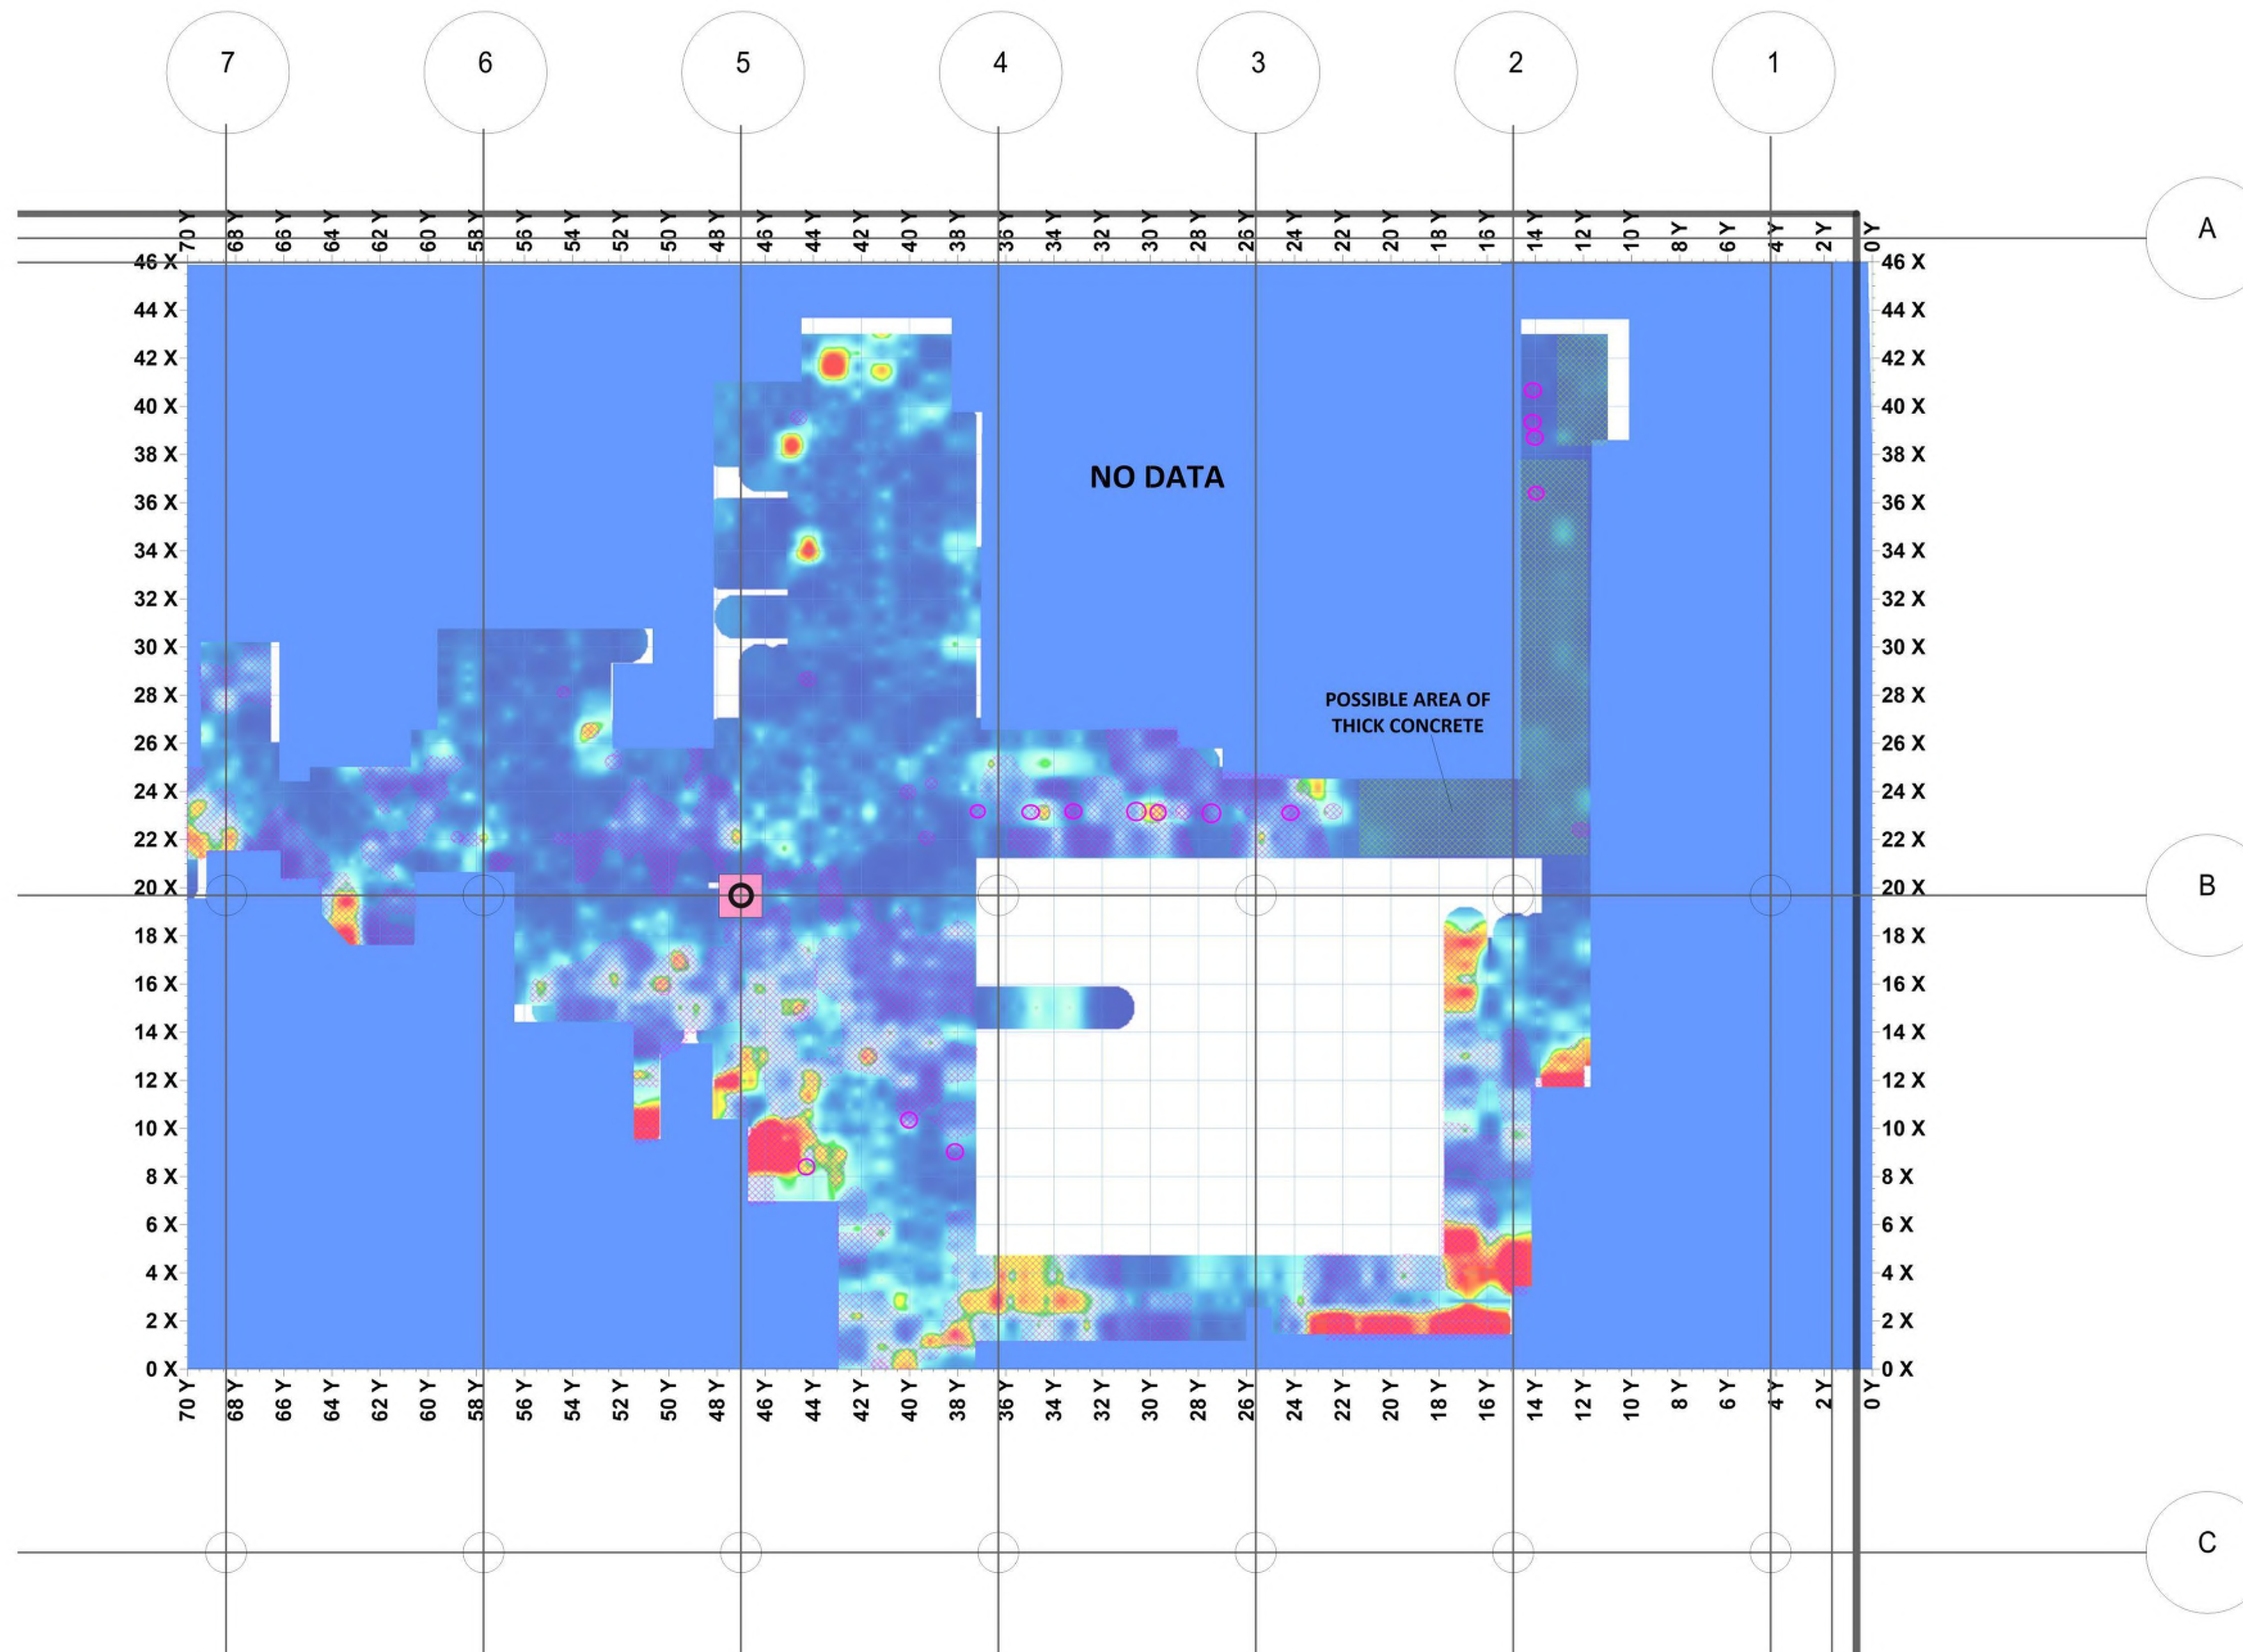
**FIGURE 7J**  
**REPRESENTATIVE DEPTH SLICE IMAGE OF**  
**500 MHz GPR DATA**  
**TO IDENTIFY TOP OF TIMBER PILES**  
**EBSCO**  
**10 ESTES STREET**  
**IPSWICH, MASSACHUSETTS**  
 Prepared for  
**SIMPSON GUMPERTZ & HEGER**  
 JUNE 2021

**DEPTH: 3.1 ft. - 3.4 ft.**

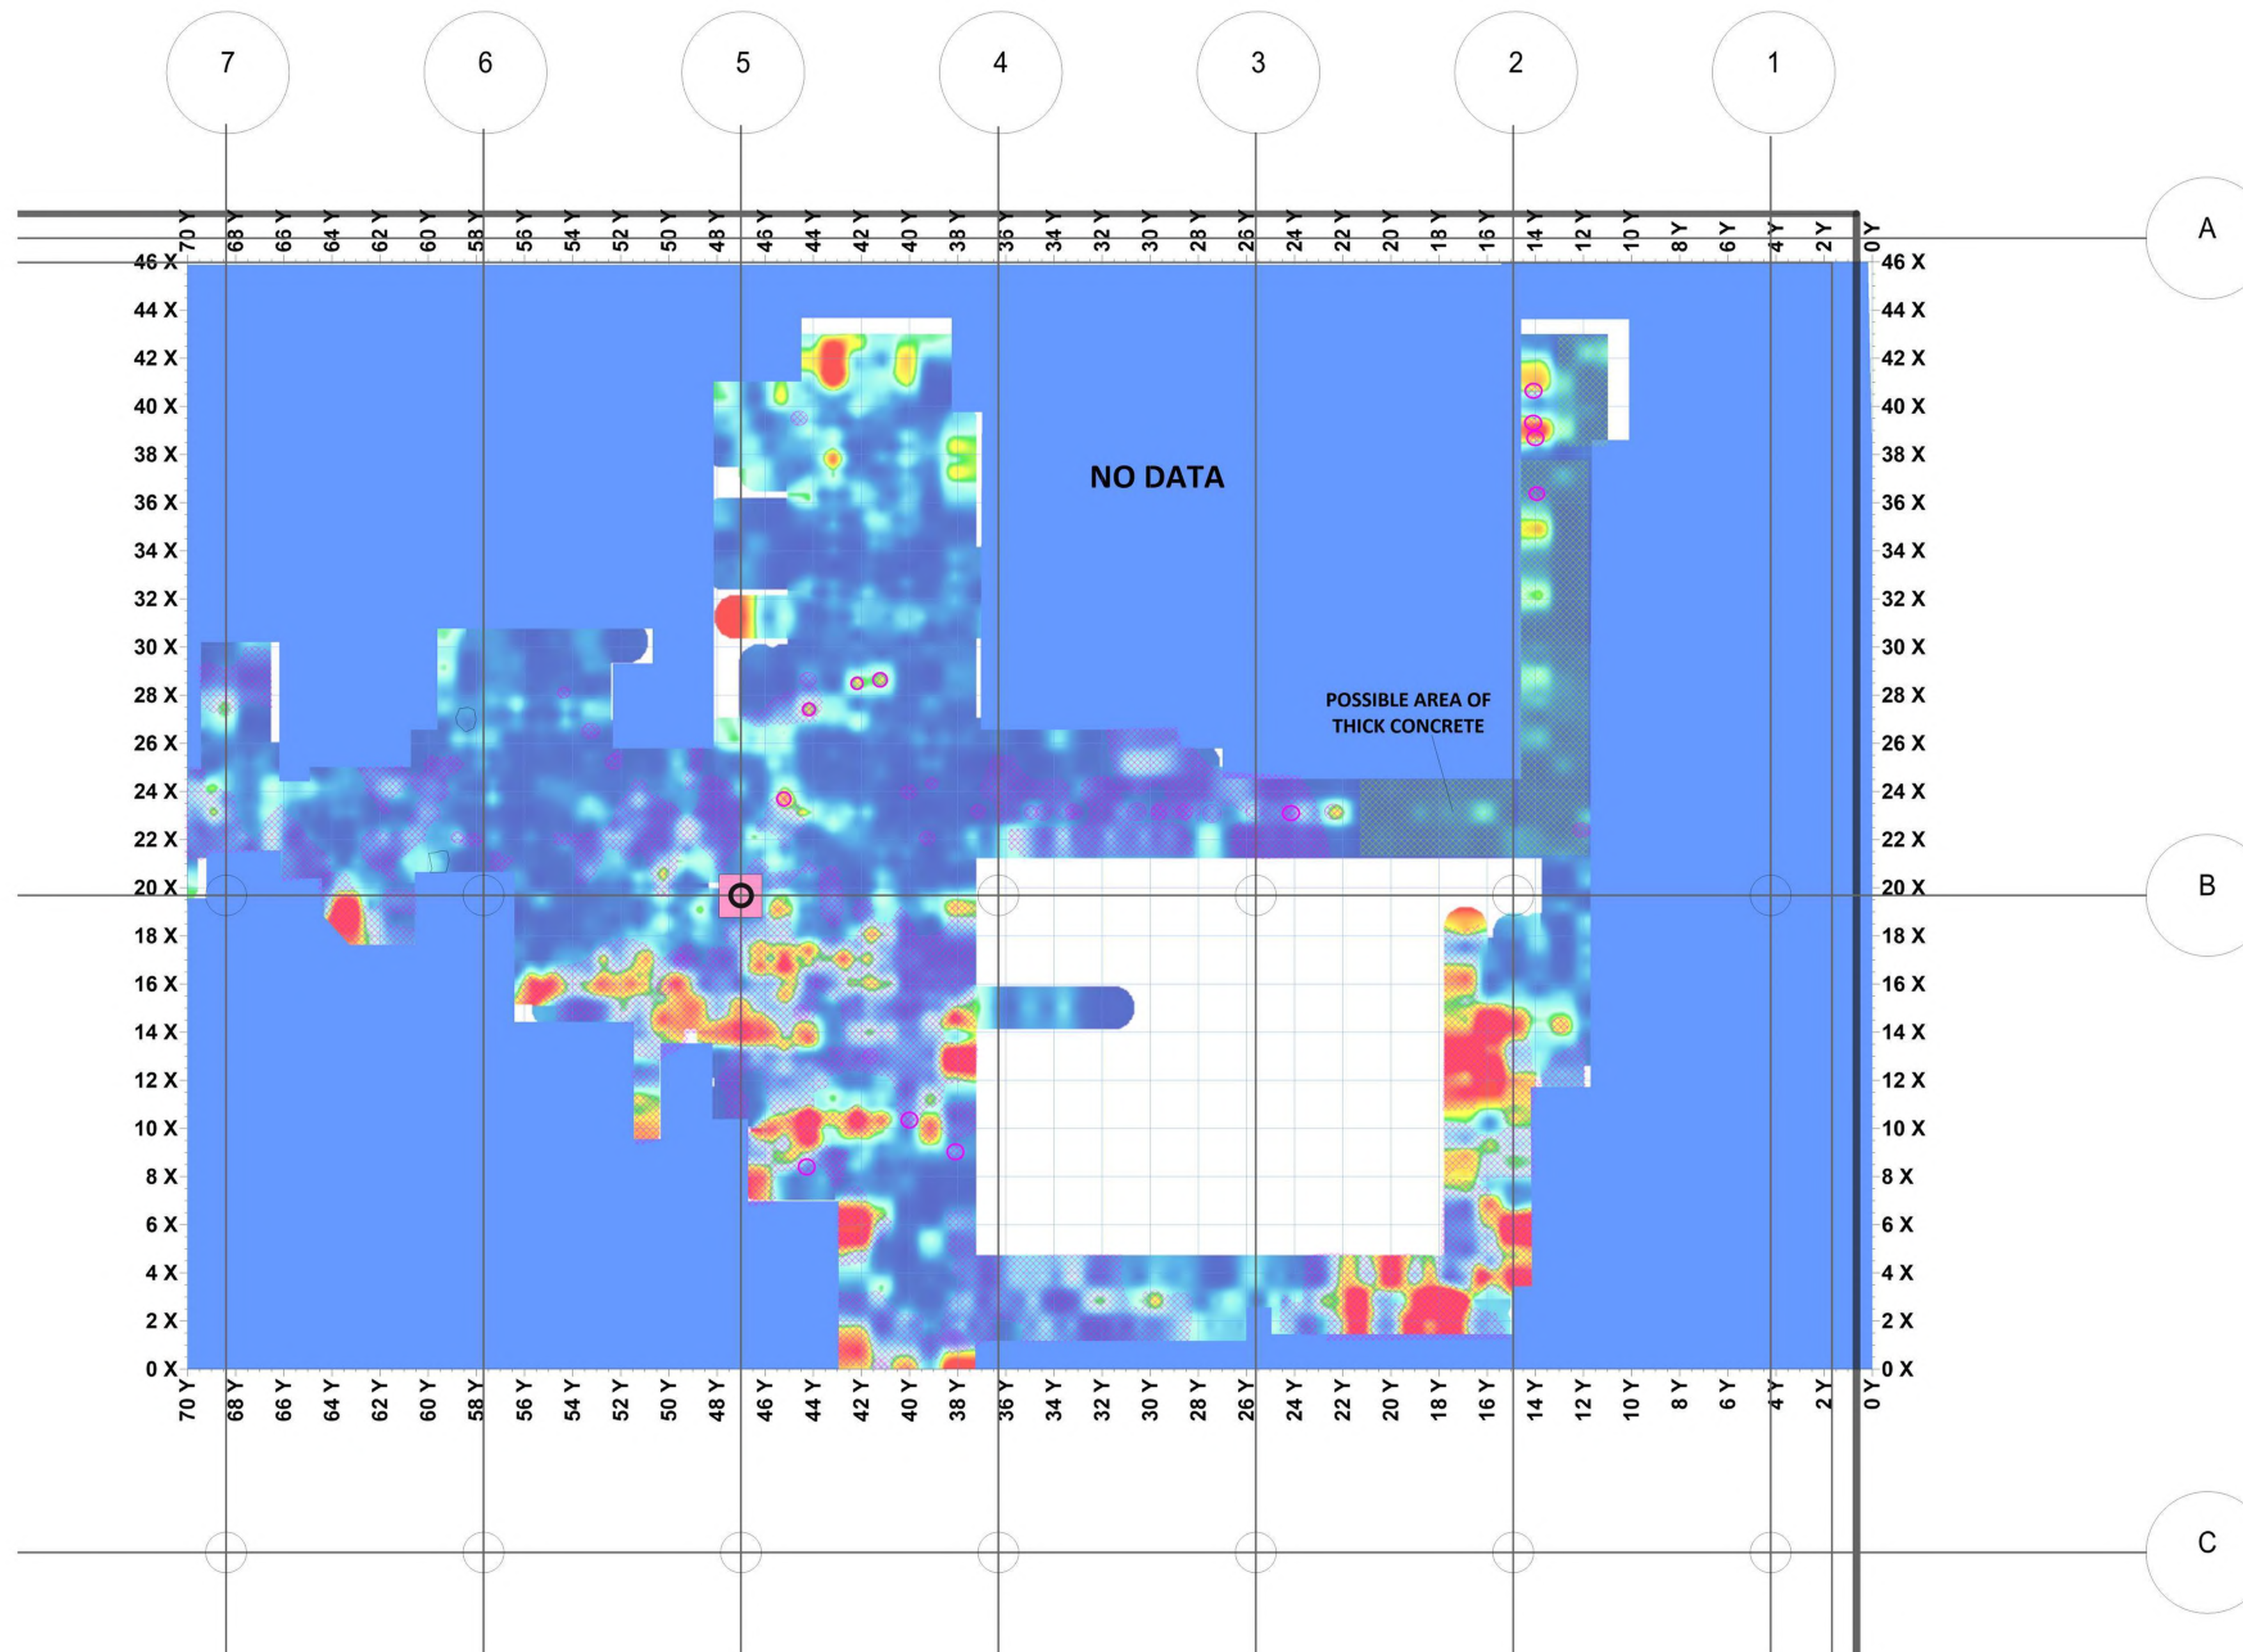
**FIGURE 7L**  
**REPRESENTATIVE DEPTH SLICE IMAGE OF**  
**500 MHz GPR DATA**  
**TO IDENTIFY TOP OF TIMBER PILES**  
**EBSCO**  
**10 ESTES STREET**  
**IPSWICH, MASSACHUSETTS**  
 Prepared for  
**SIMPSON GUMPERTZ & HEGER**  
 JUNE 2021

**DEPTH: 4.7 ft. - 4.9 ft.**

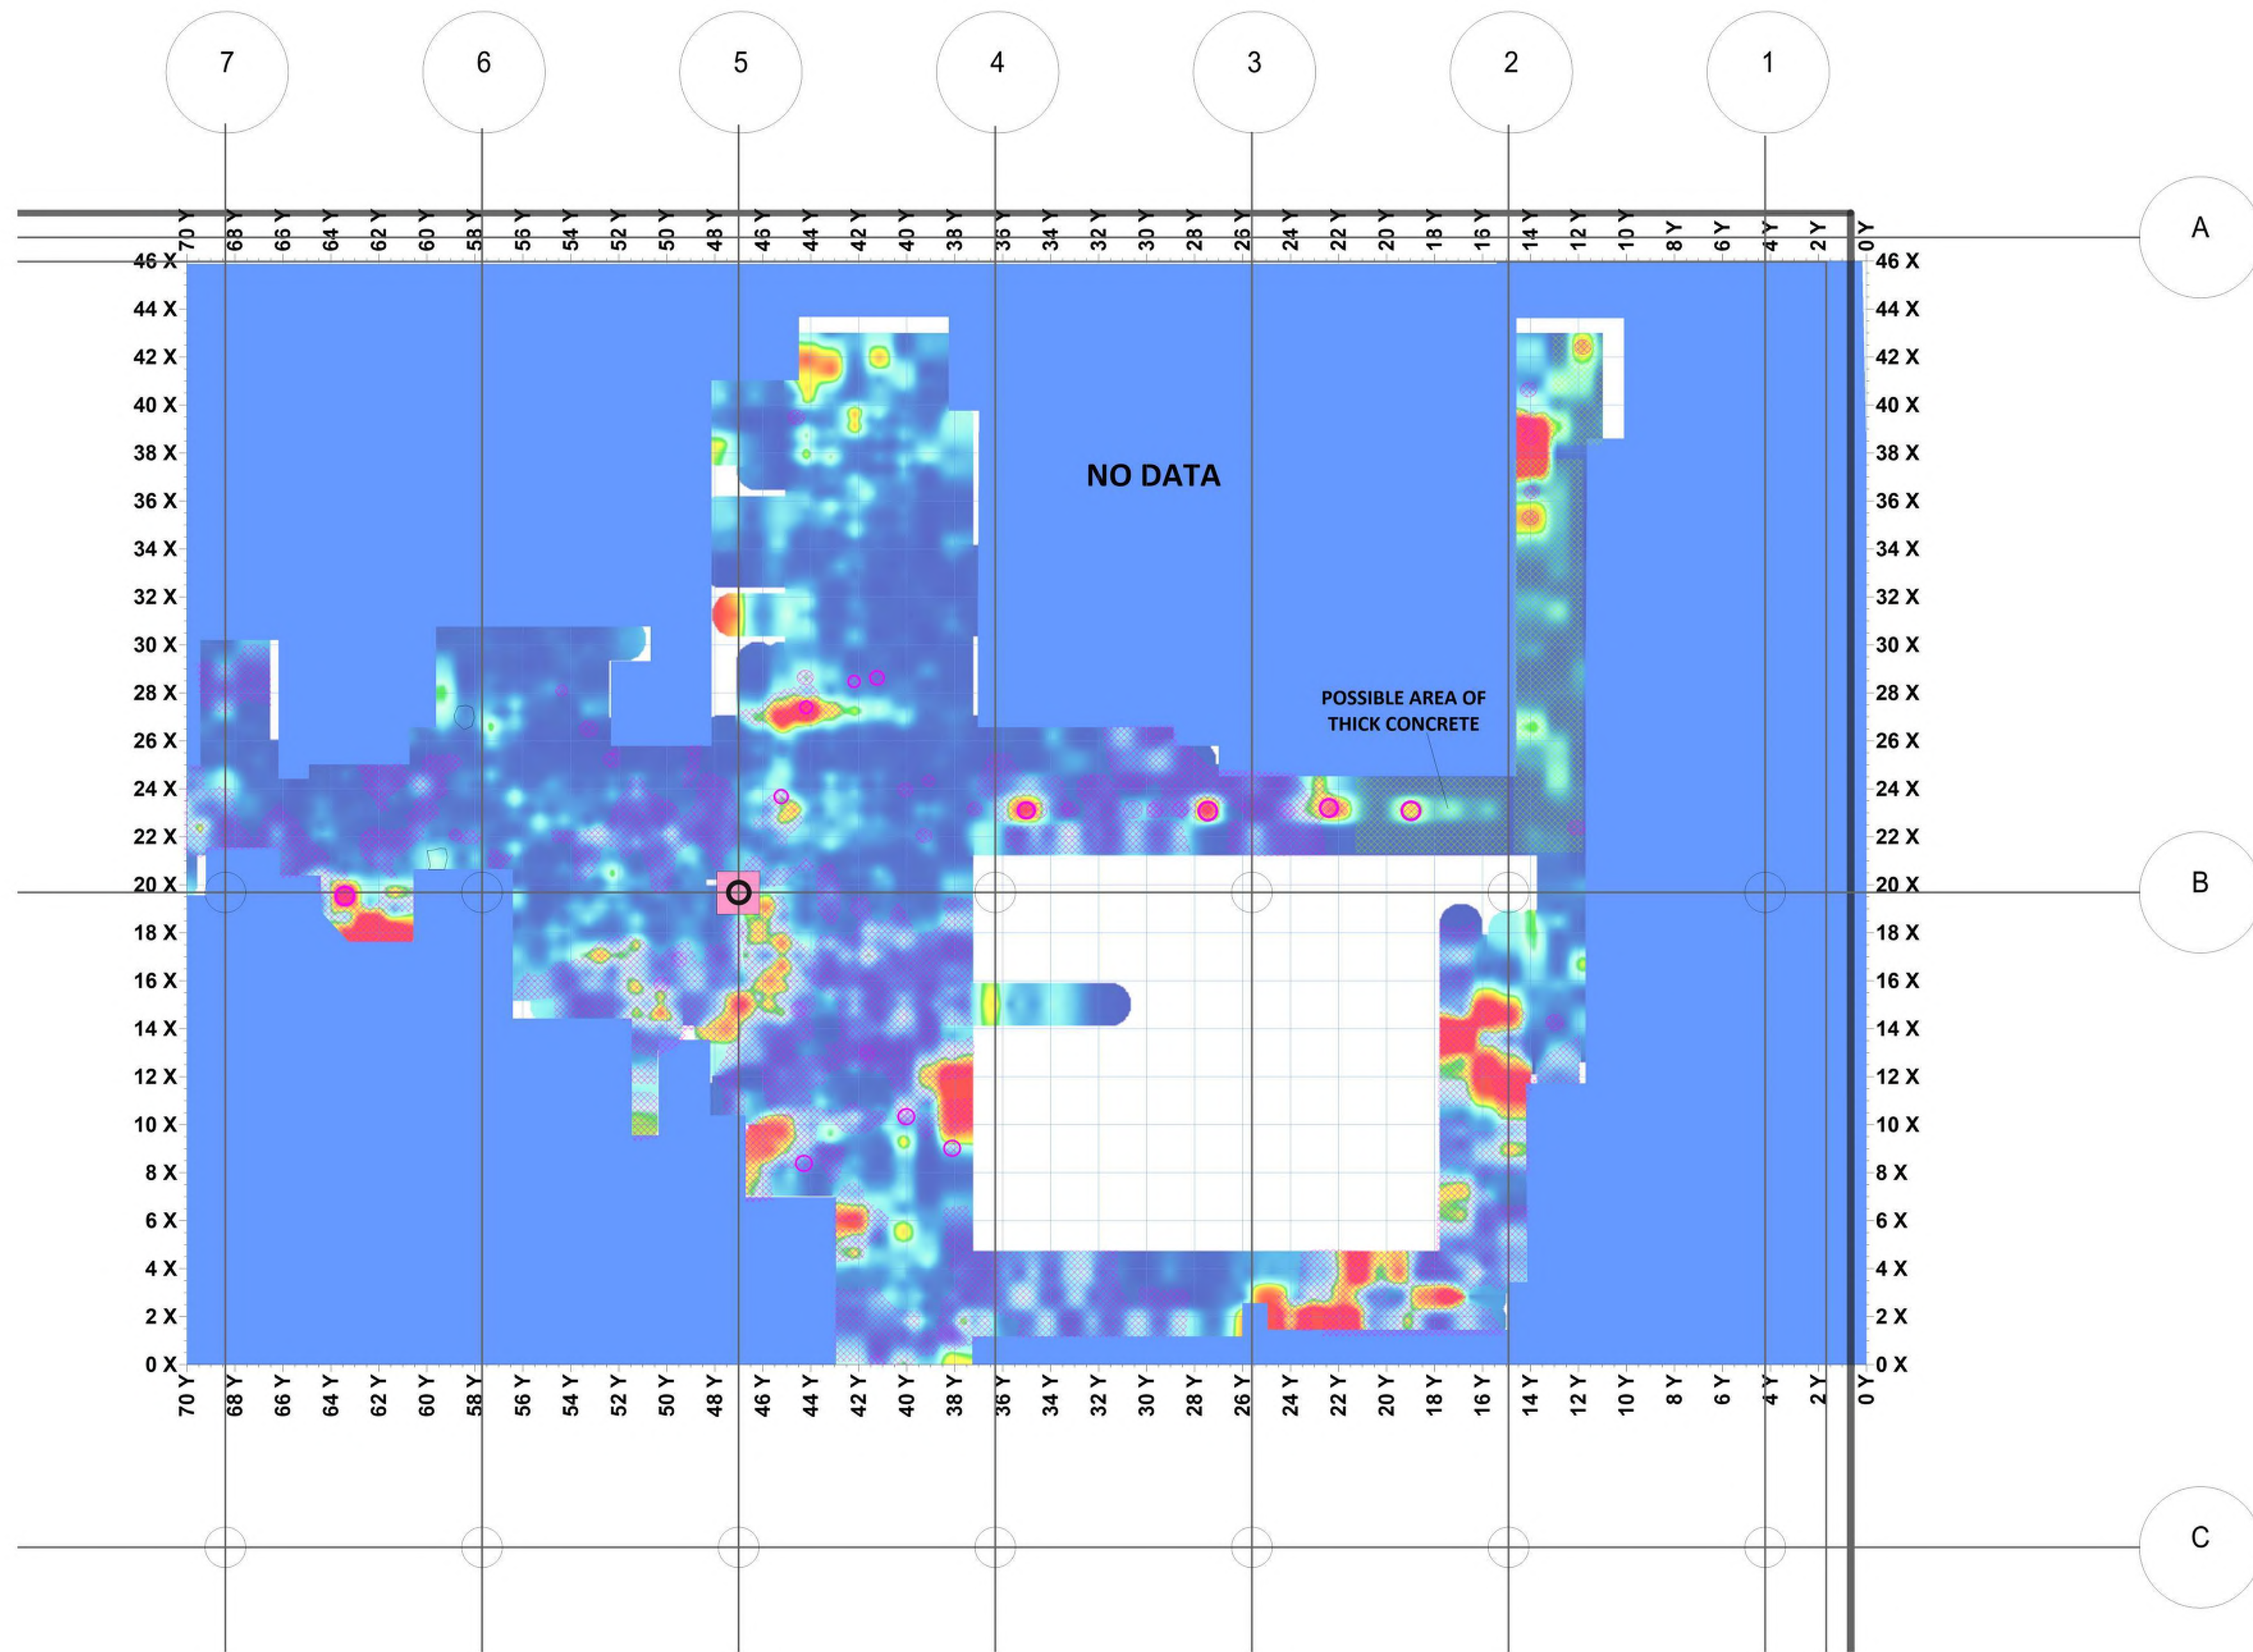
**FIGURE 7M**  
**REPRESENTATIVE DEPTH SLICE IMAGE OF**  
**500 MHz GPR DATA**  
**TO IDENTIFY TOP OF TIMBER PILES**  
**EBSCO**  
**10 ESTES STREET**  
**IPSWICH, MASSACHUSETTS**  
 Prepared for  
**SIMPSON GUMPERTZ & HEGER**  
 JUNE 2021

**DEPTH: 5.5 ft. - 5.7 ft.**

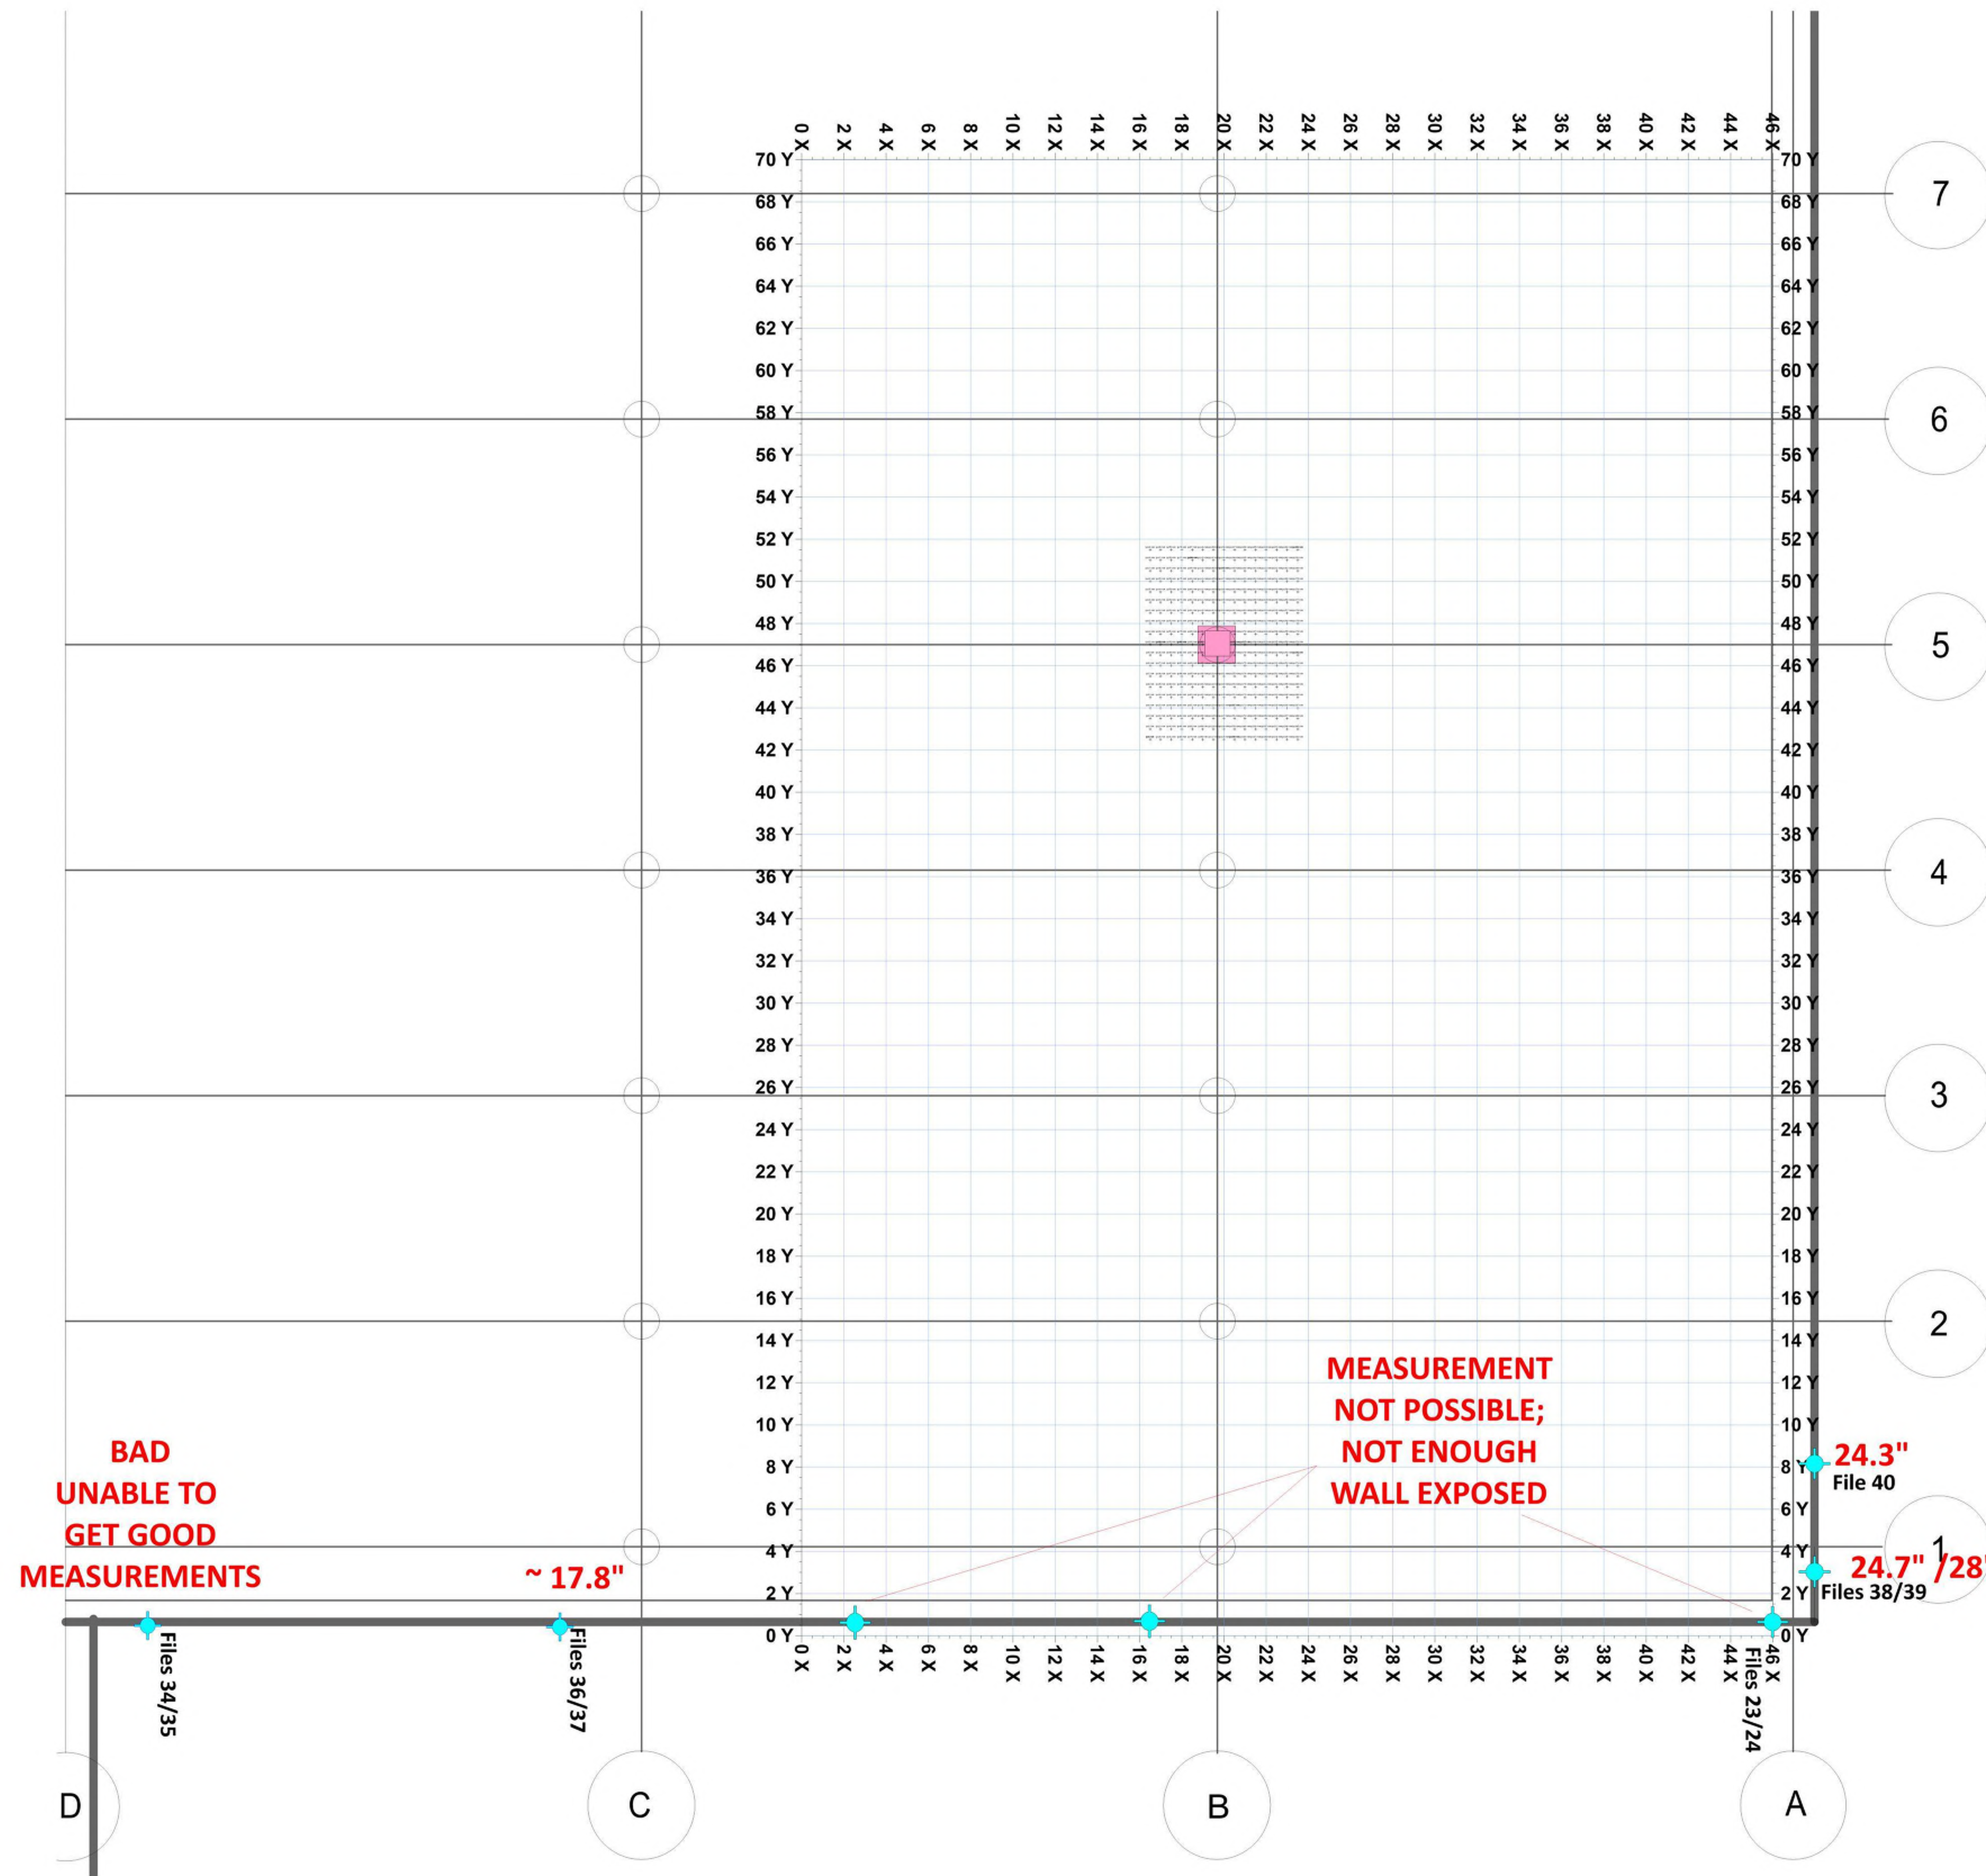
**FIGURE 9**  
**THICKNESS AT THE TOP OF FOUNDATION WALL FROM IMPACT ECHO**  
 EBSCO  
 10 ESTES STREET  
 IPSWICH, MASSACHUSETTS

Proximity to the western wall prevented unusable data due to high noise (ringing) relative to the signal amplitude.
